Ford Super Duty ESOF Hub Service

2004 F250 4x4 XLT Sport Crew Cab

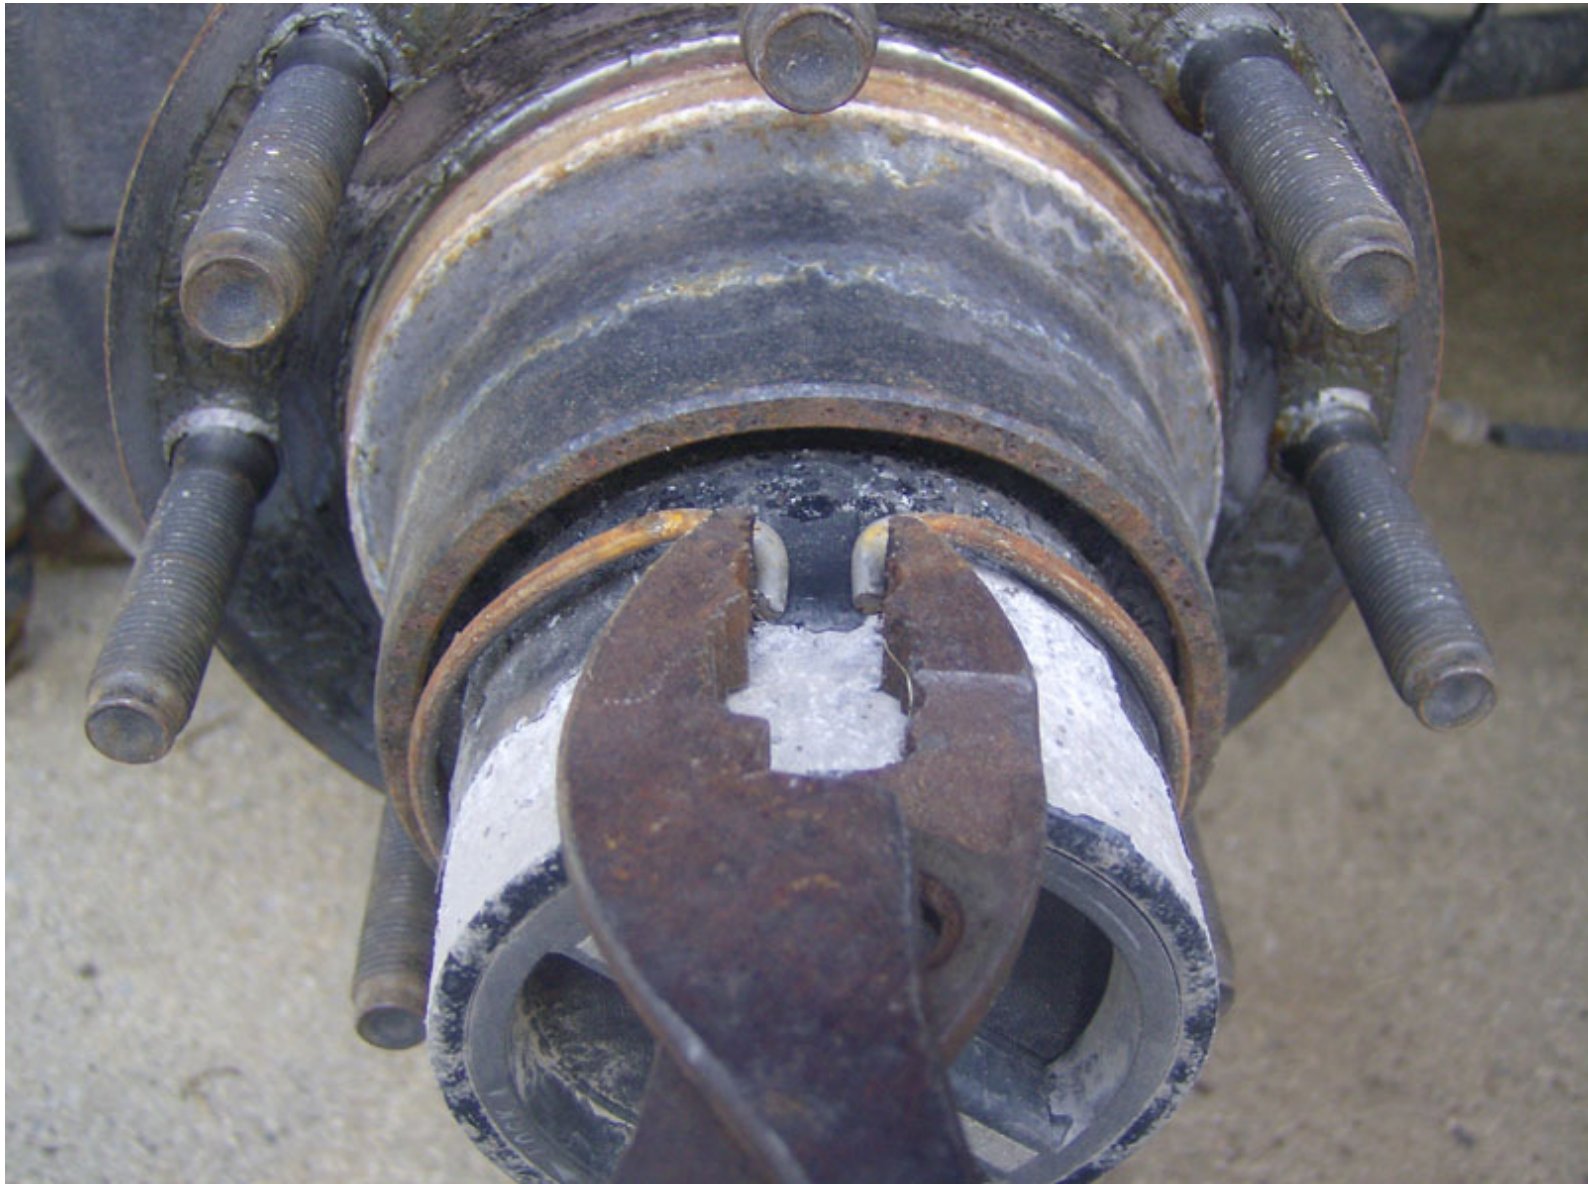
Remove the hub assembly retaining ring with a pair of pliers.

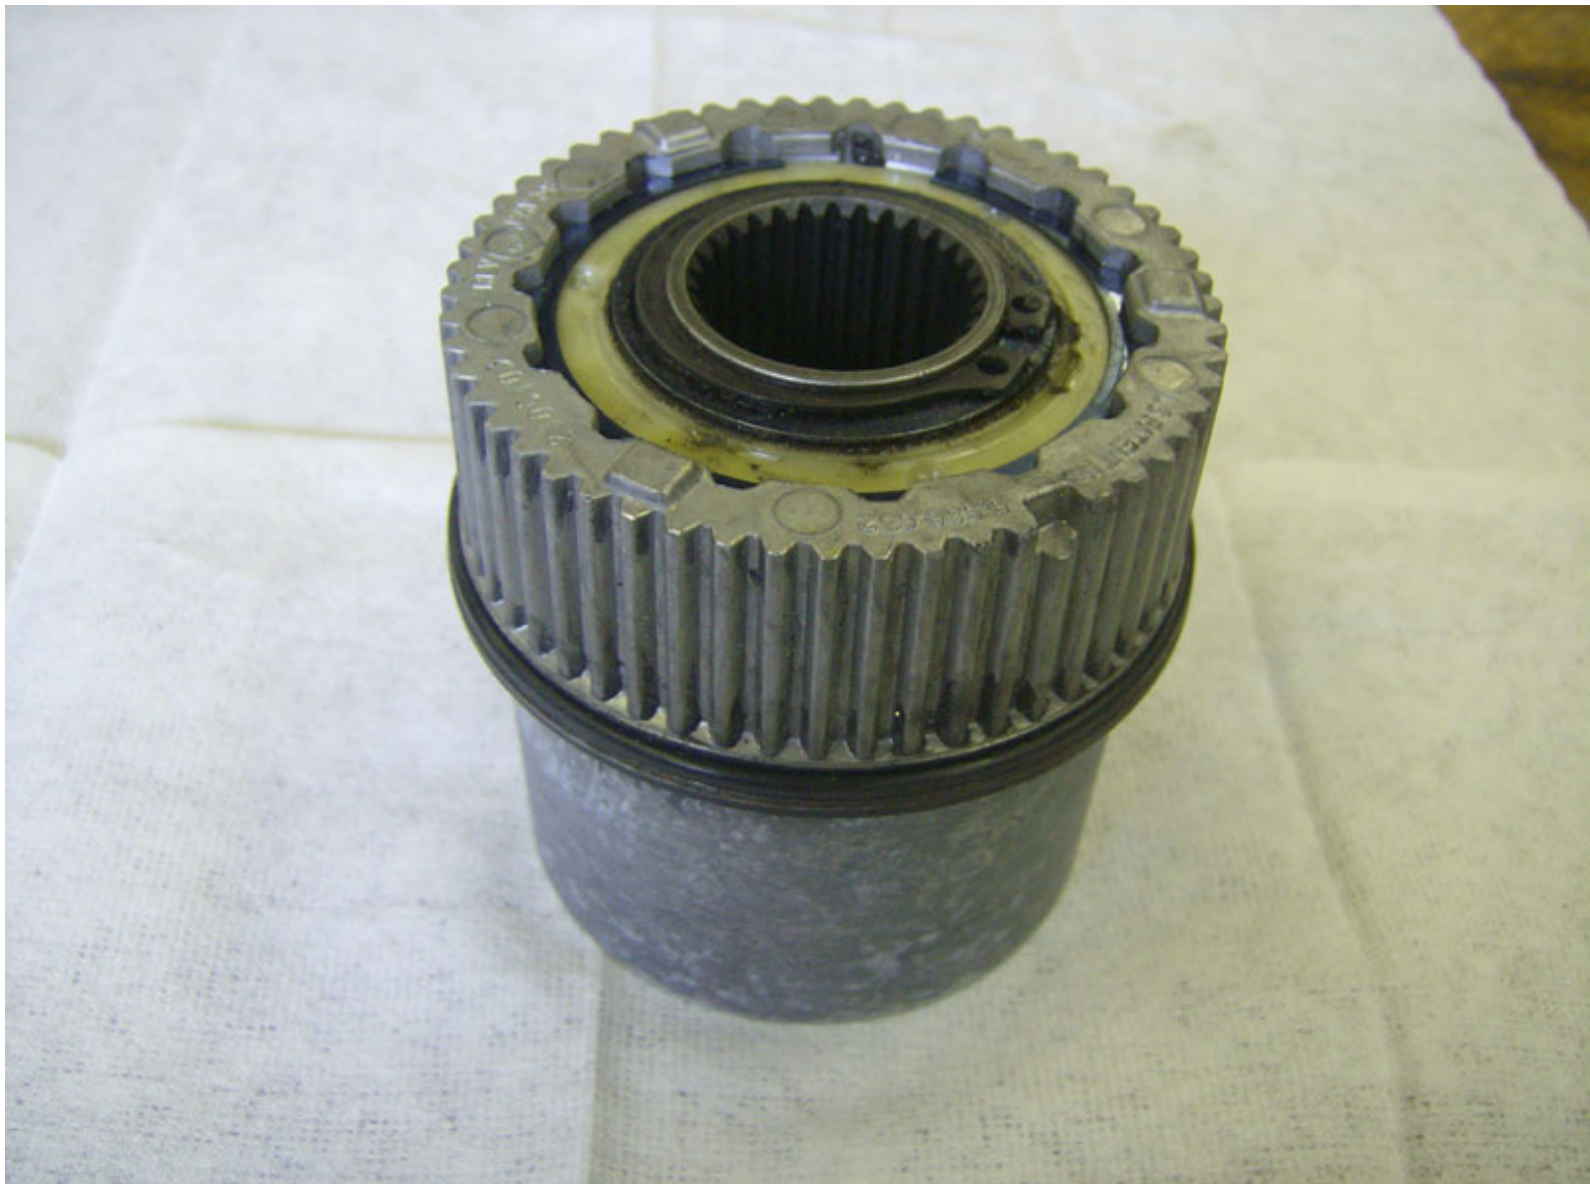
With the retaining ring removed, the hub will just pull out. I've read where sometimes this takes some persuasion, but mine basically pulled right out. The paint was flaking really bad, so I scraped off the loose paint and cleaned up the white corrosion with a Scotchbrite pad.

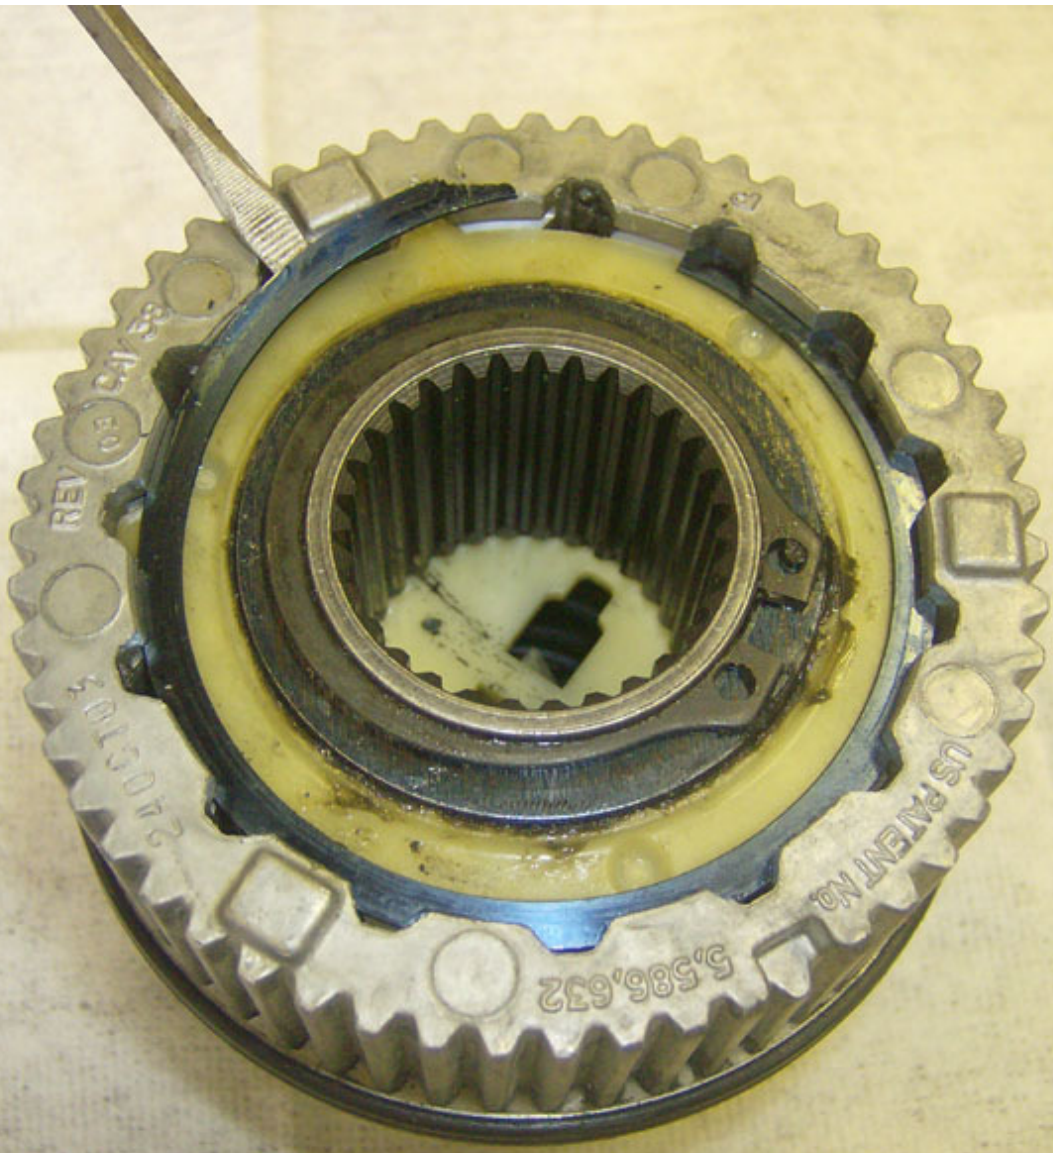
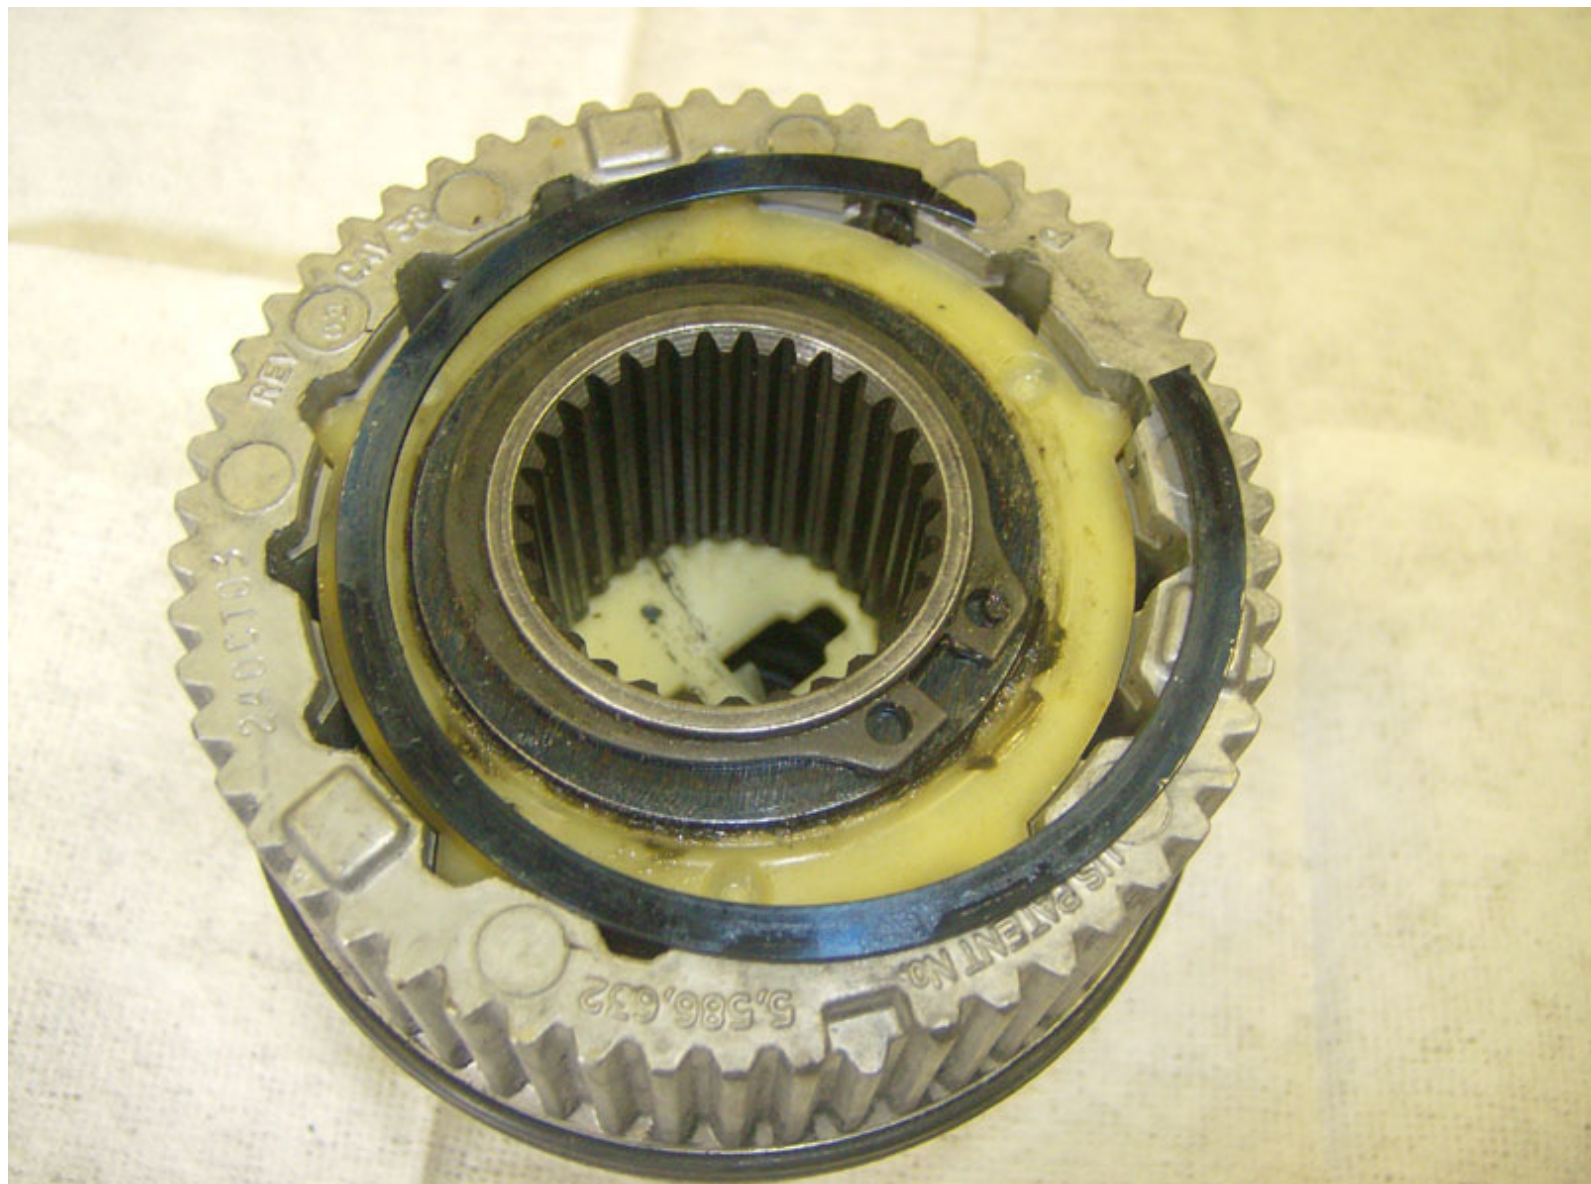
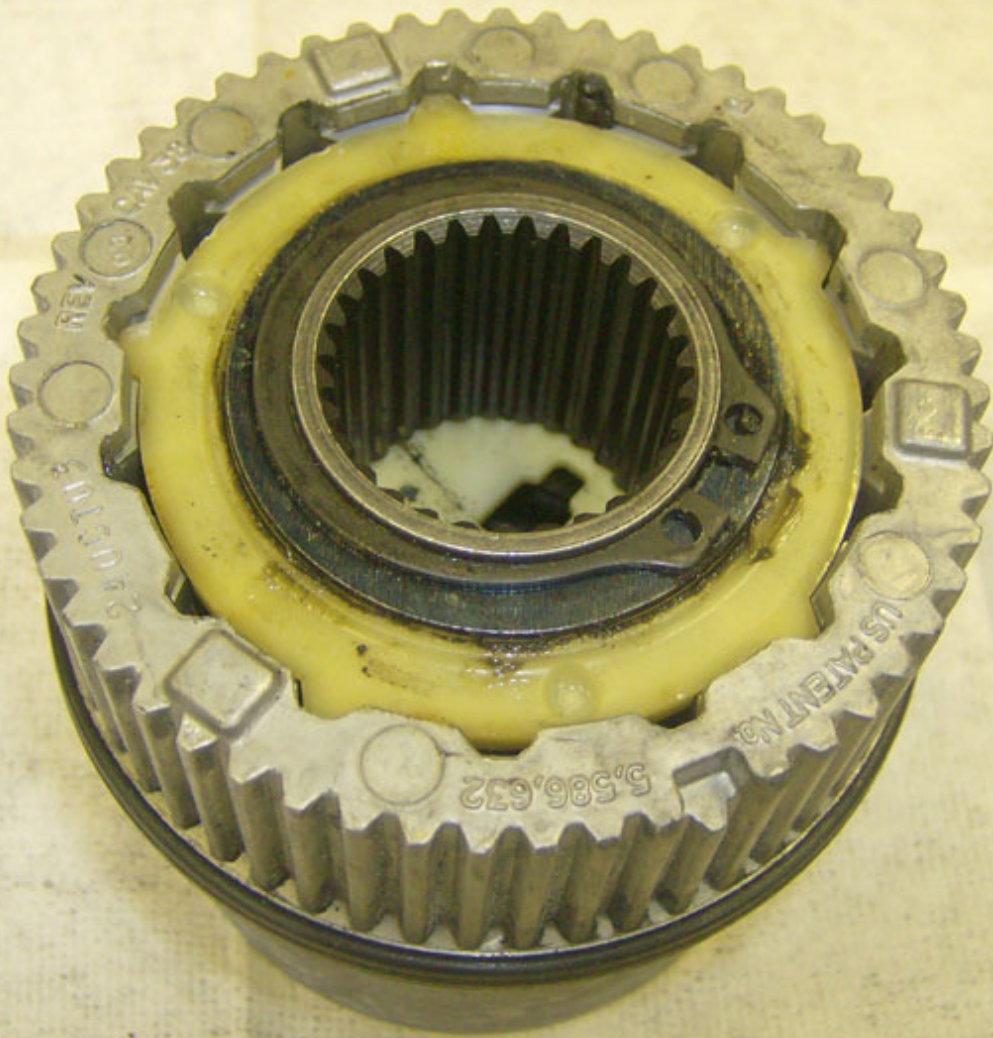
Start by removing the large clip ring that holds everything in. Just pry it up with a small screwdriver and work it around the perimeter until its out.

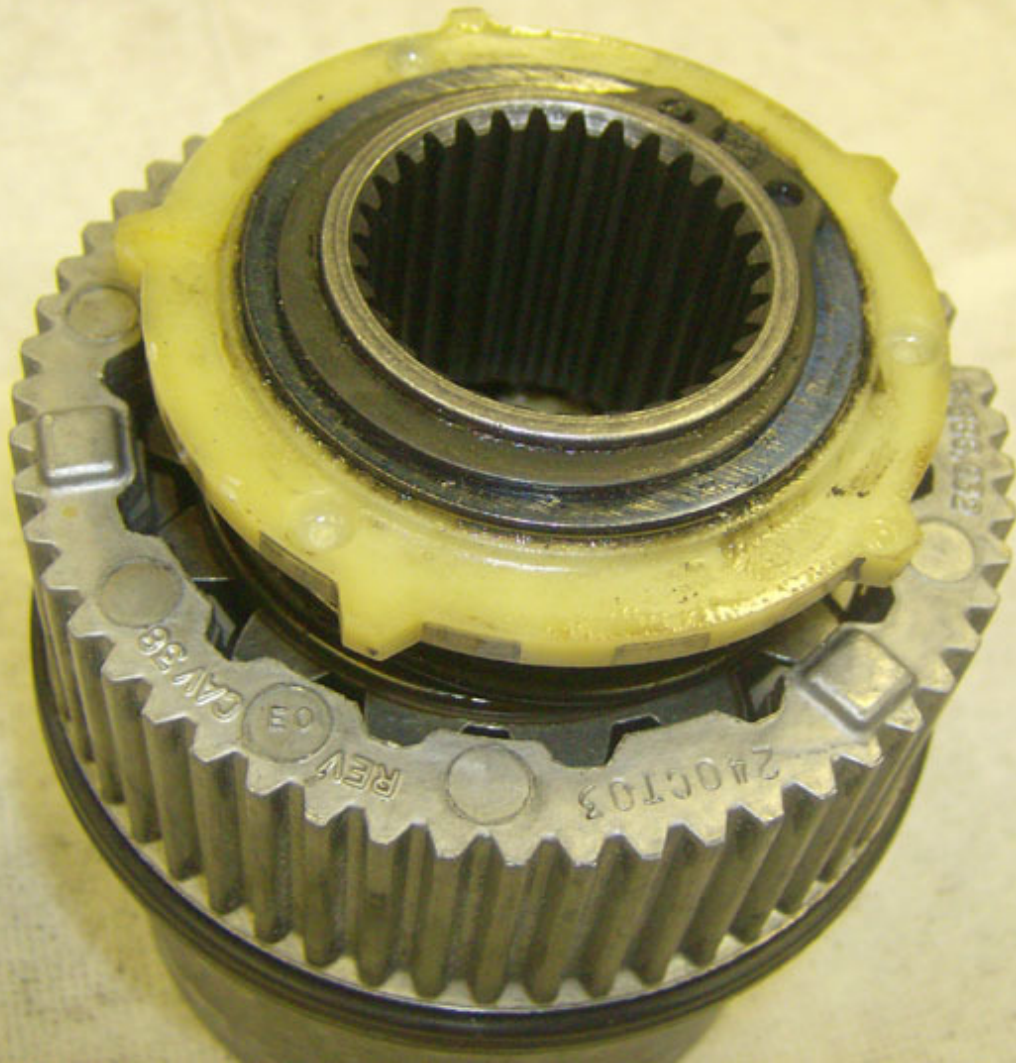
Now the internals can be removed from the hub. This may take a little work but it will pop up out of there.

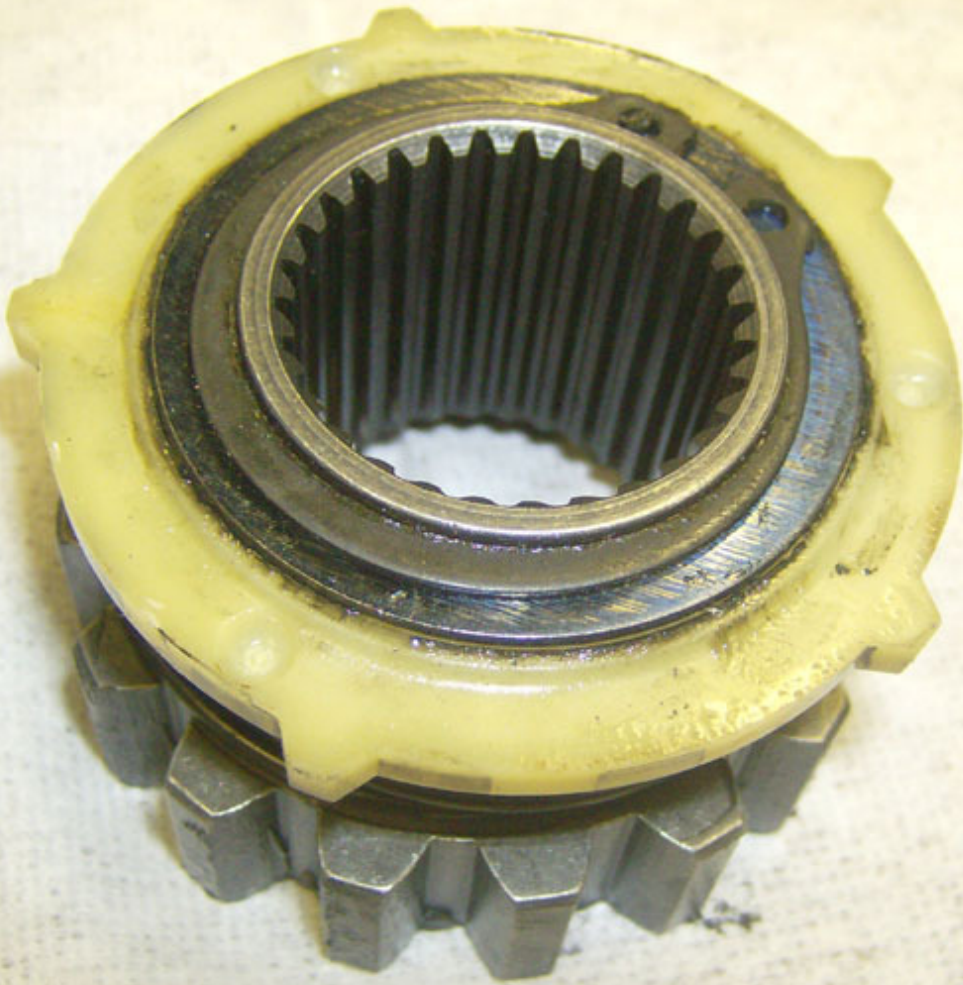
This is the assembly that was just removed from the hub.

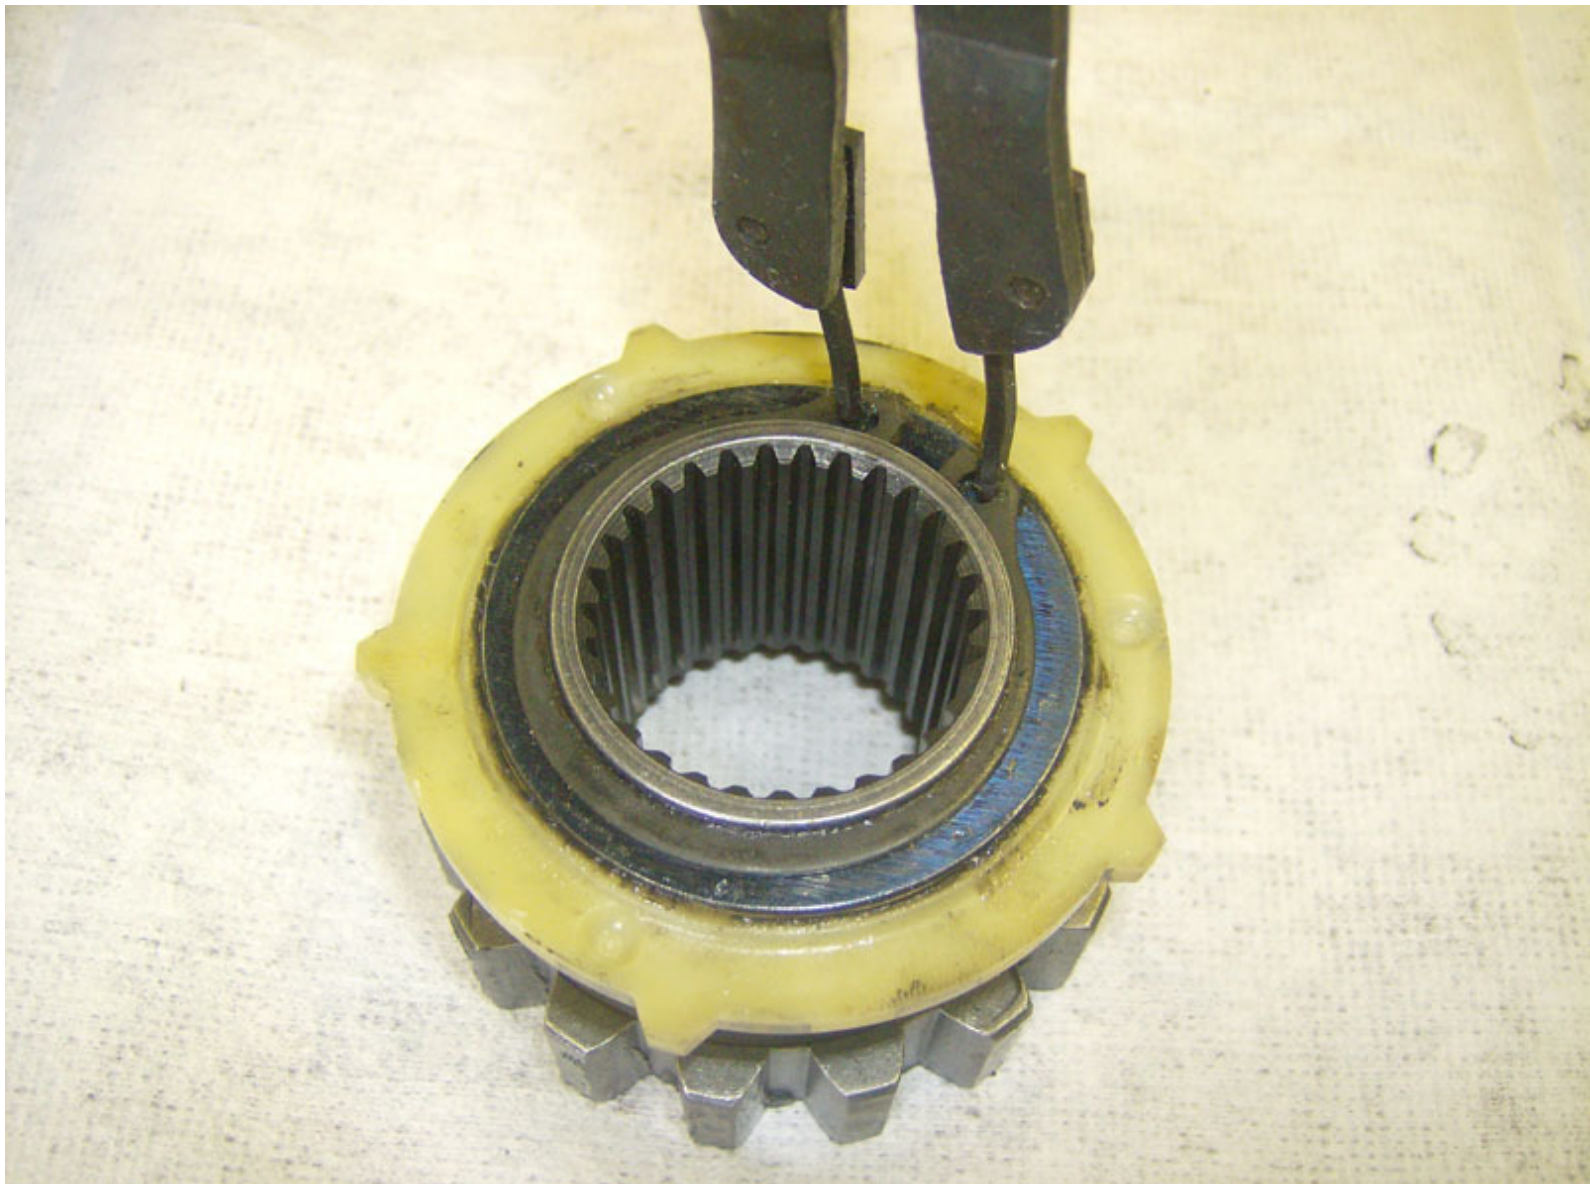
Next, disassemble the internals by first removing the snap ring and then remove the thrust washer, the plastic/bearing assembly and the other thrust washer.

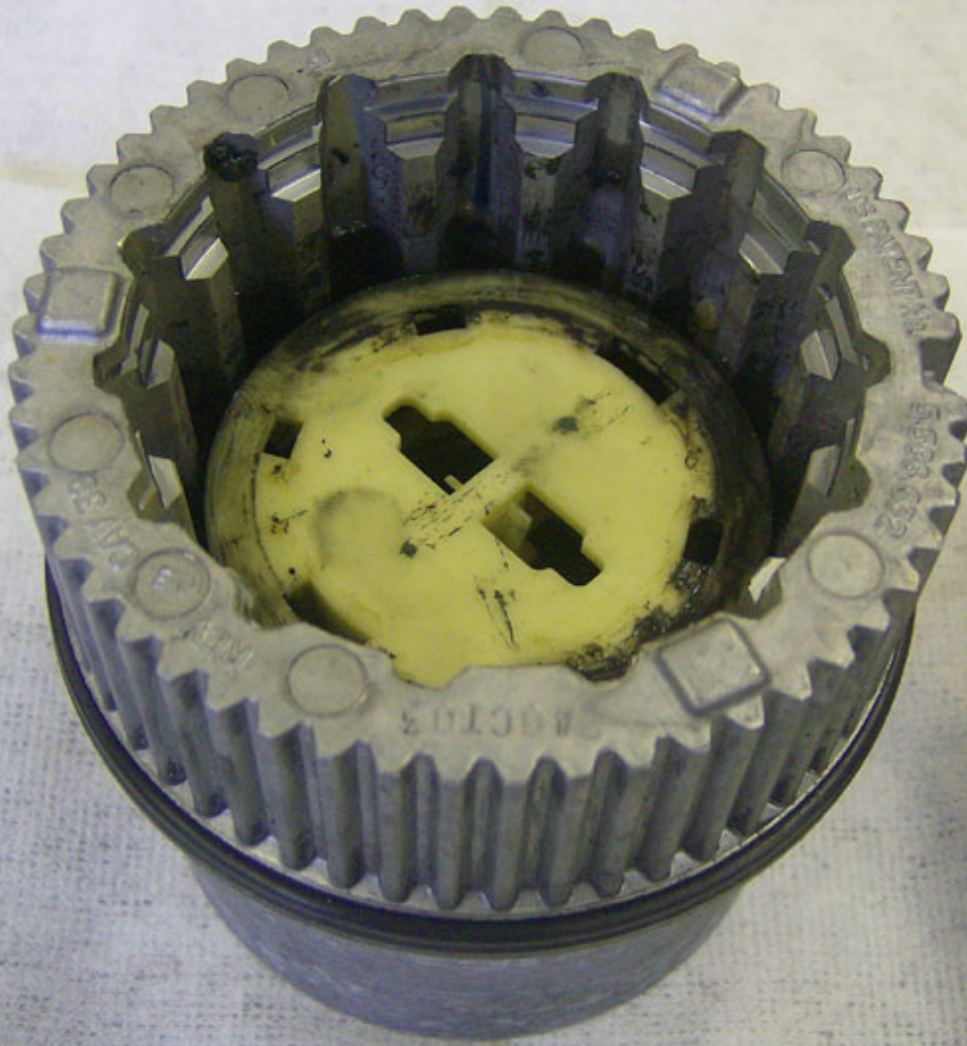
The plastic assembly that is still inside the hub can be removed by simply lifting it out with a pair of needlenose pliers. There's a small plastic boss under this assembly that holds it in place, but pulling up with the pliers will separate it.

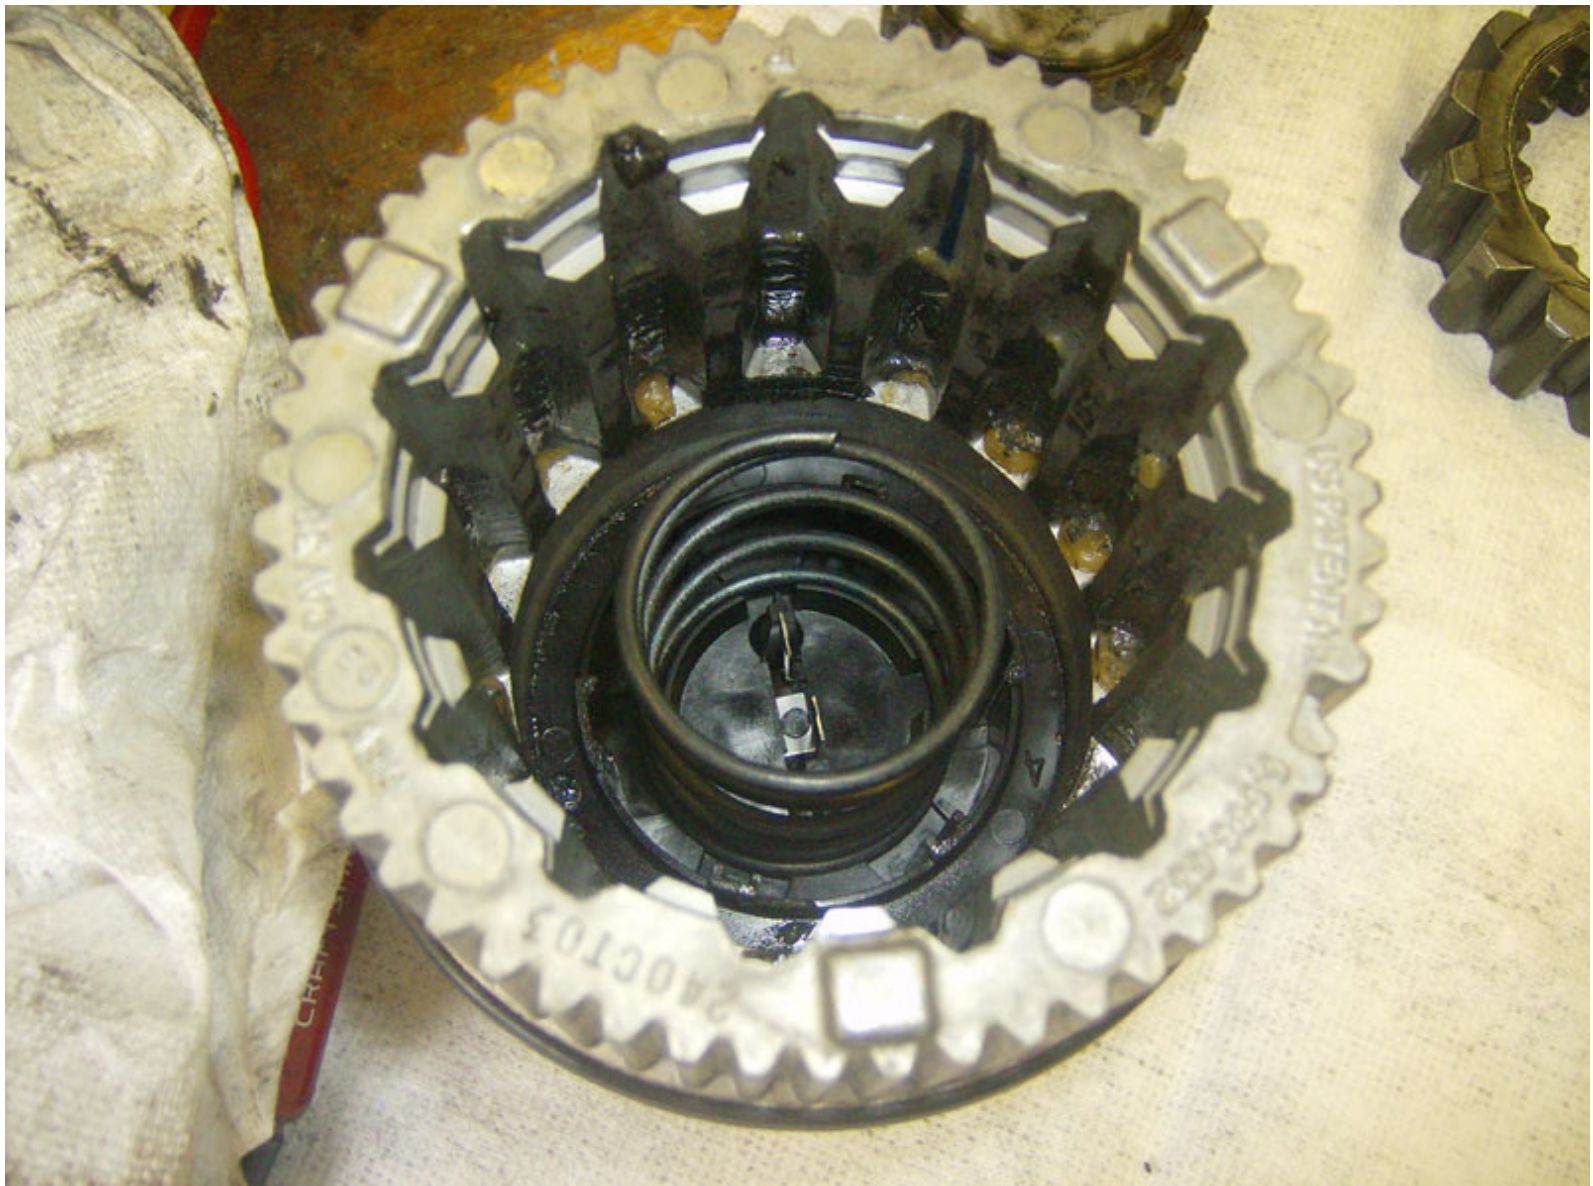
On this particular hub, the plastic assembly at the bottom was separated. Once you pull out the spring and the other plastic piece, you can snap the assembly back together.

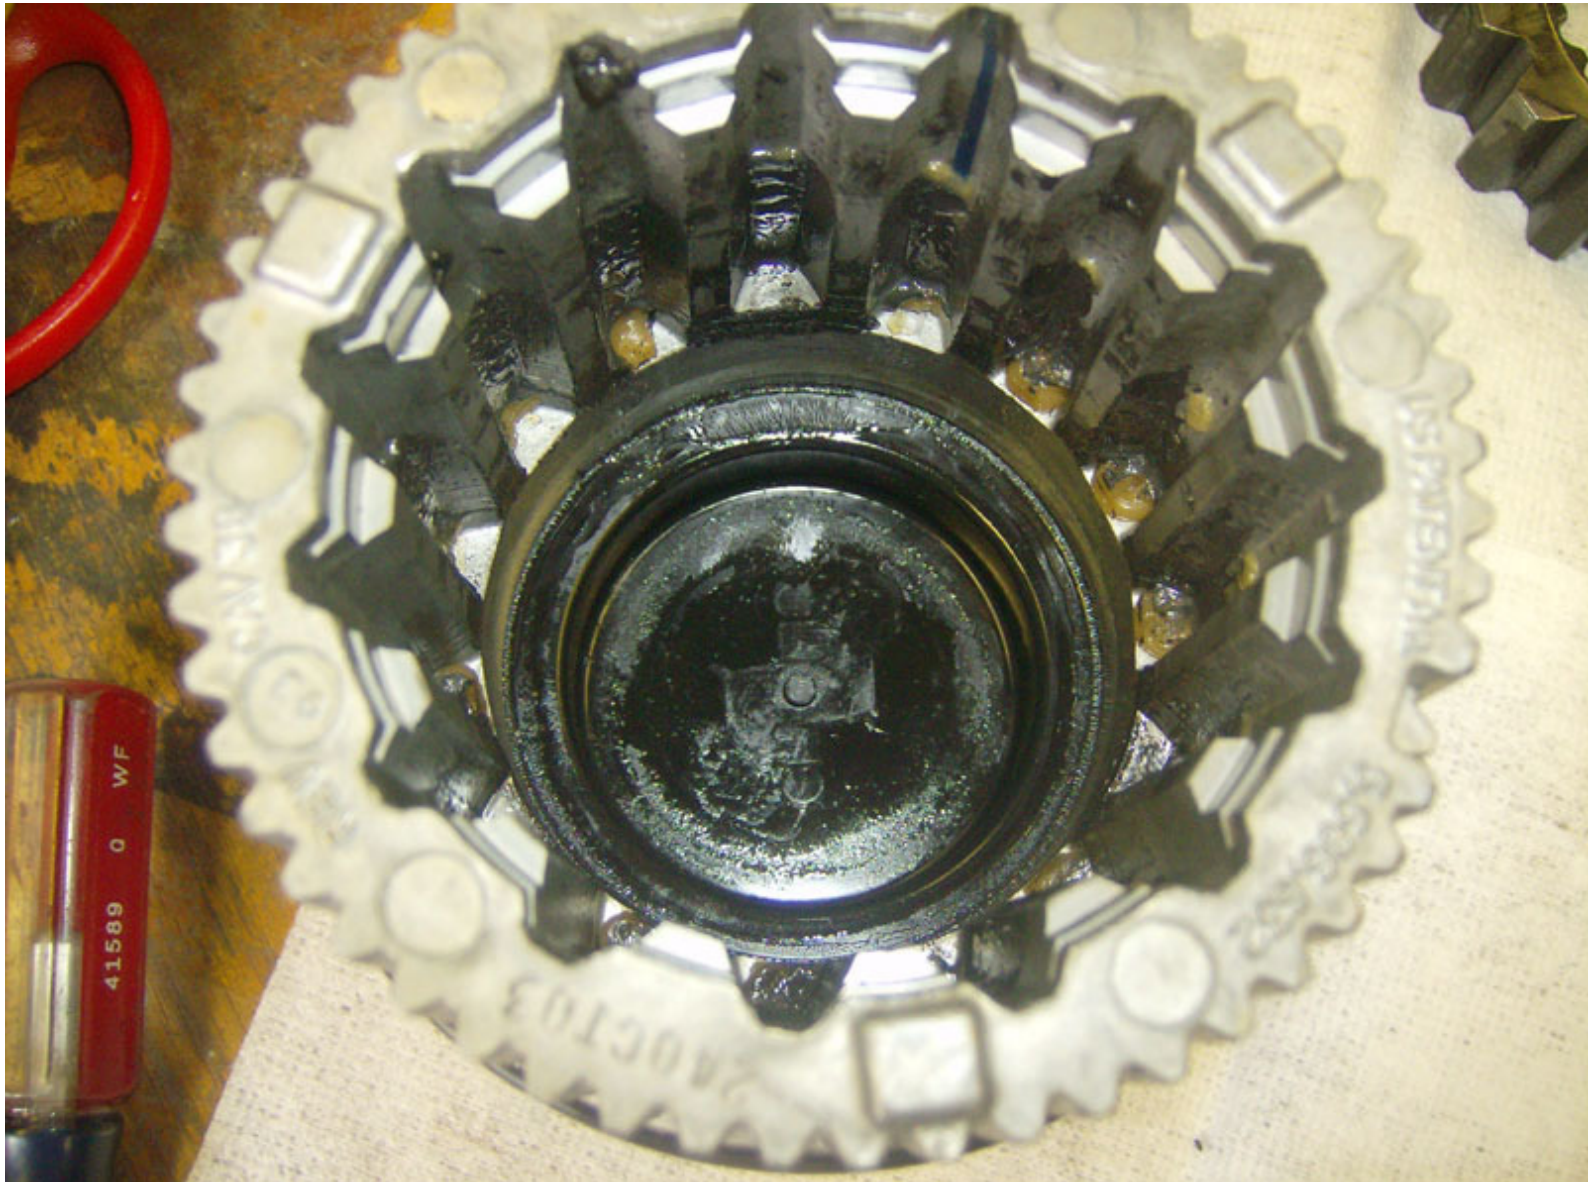
You can see the small plastic boss in this picture.

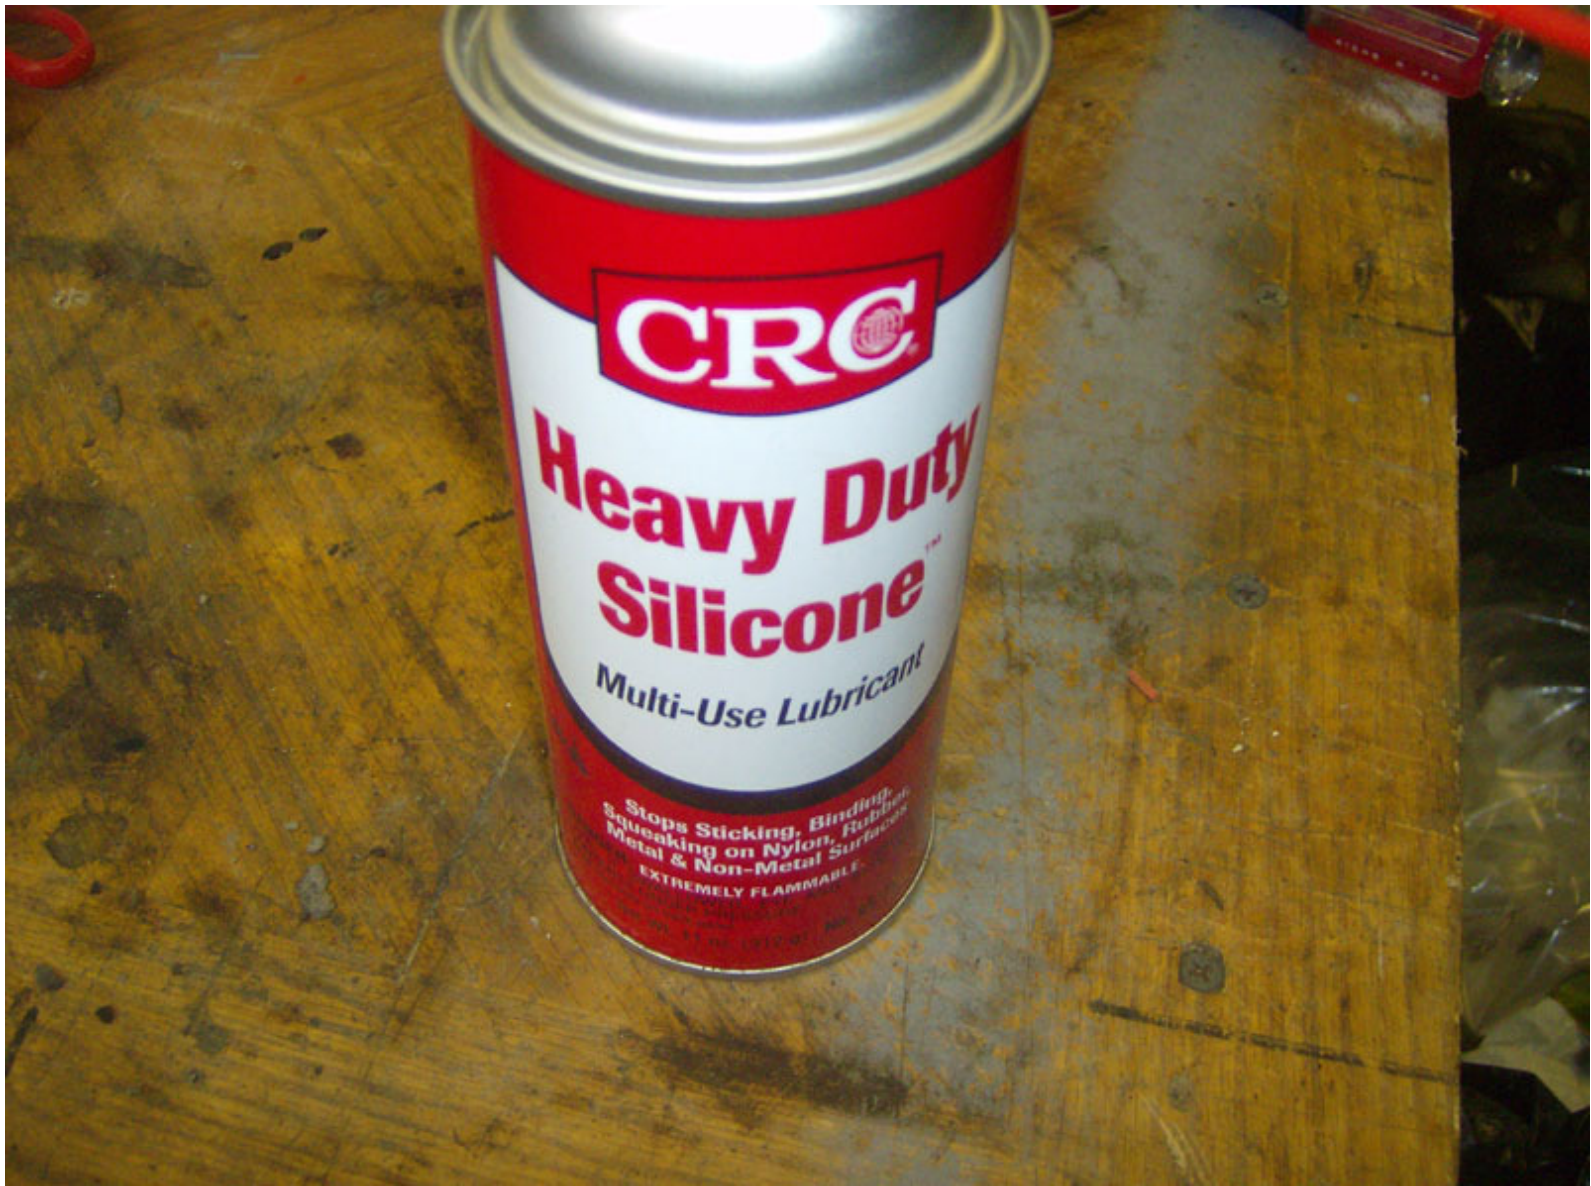
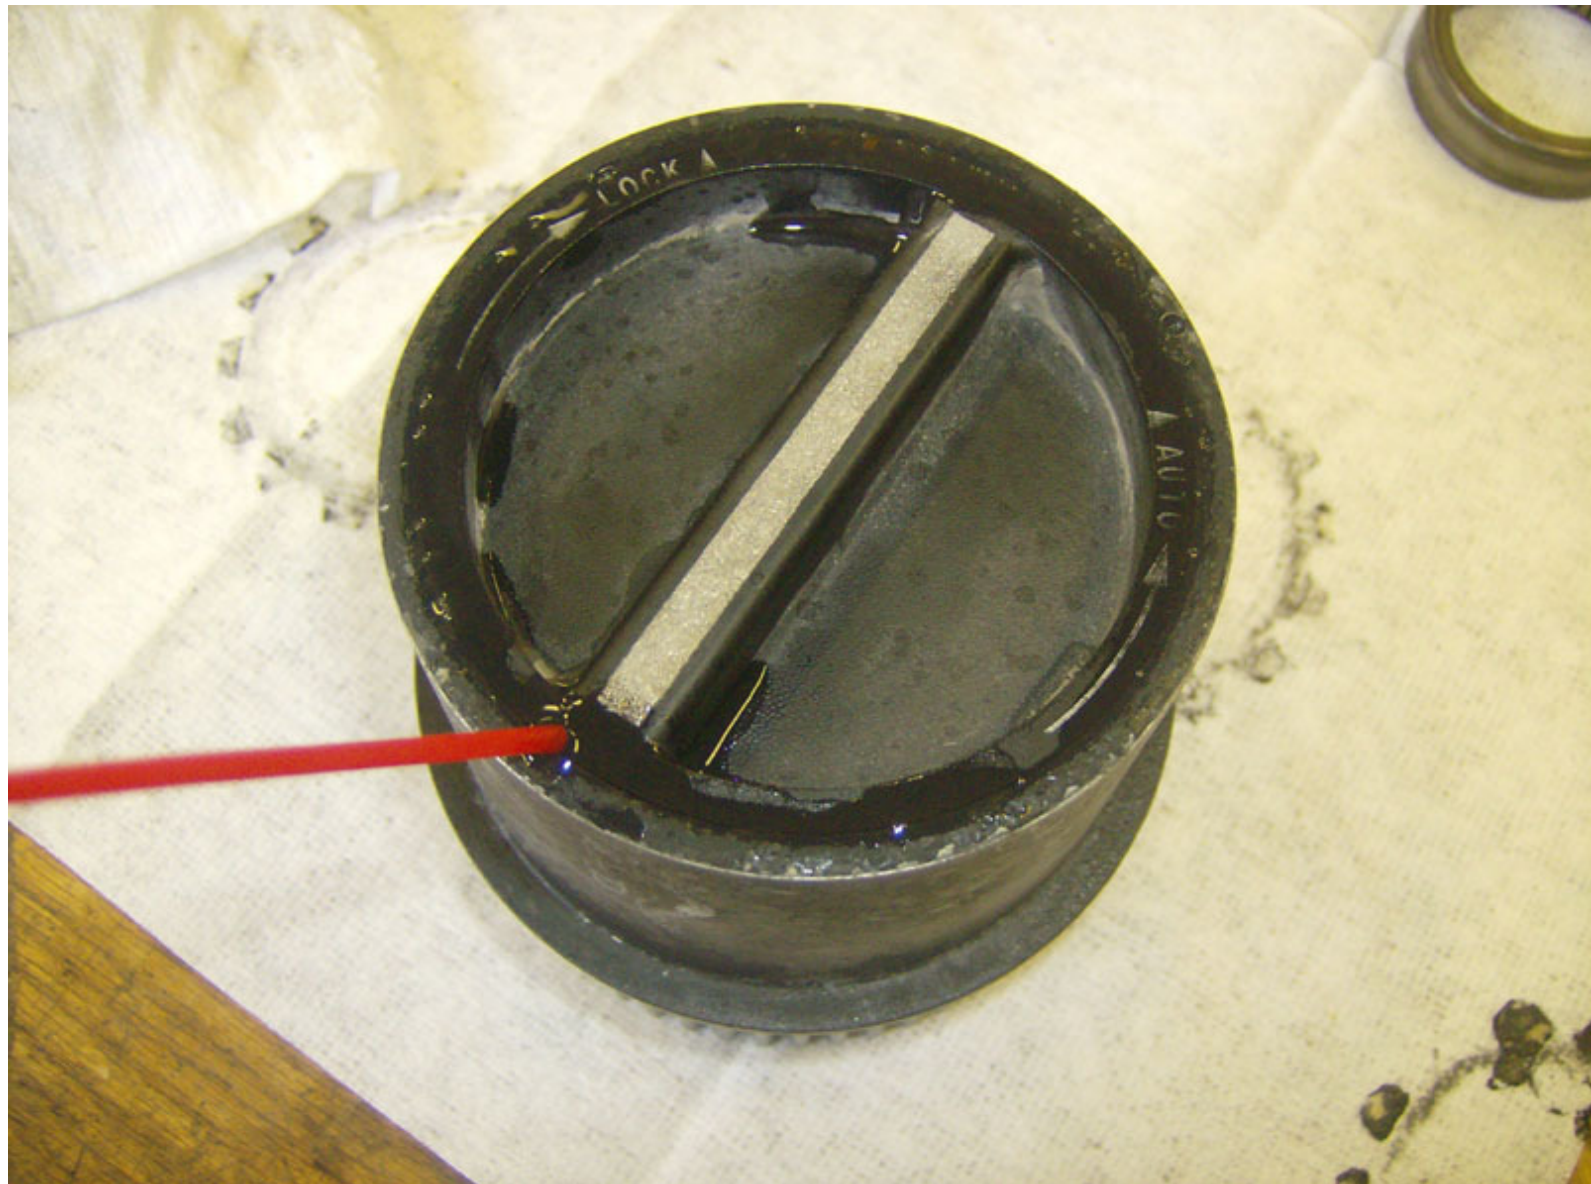
I used CRC silicone lube to free up the hub selector knob. As is usually the case, my hub knobs were getting hard to turn. After gently spraying this on the inside and around the perimeter on the outside (see second pic below), I was able to work it free.

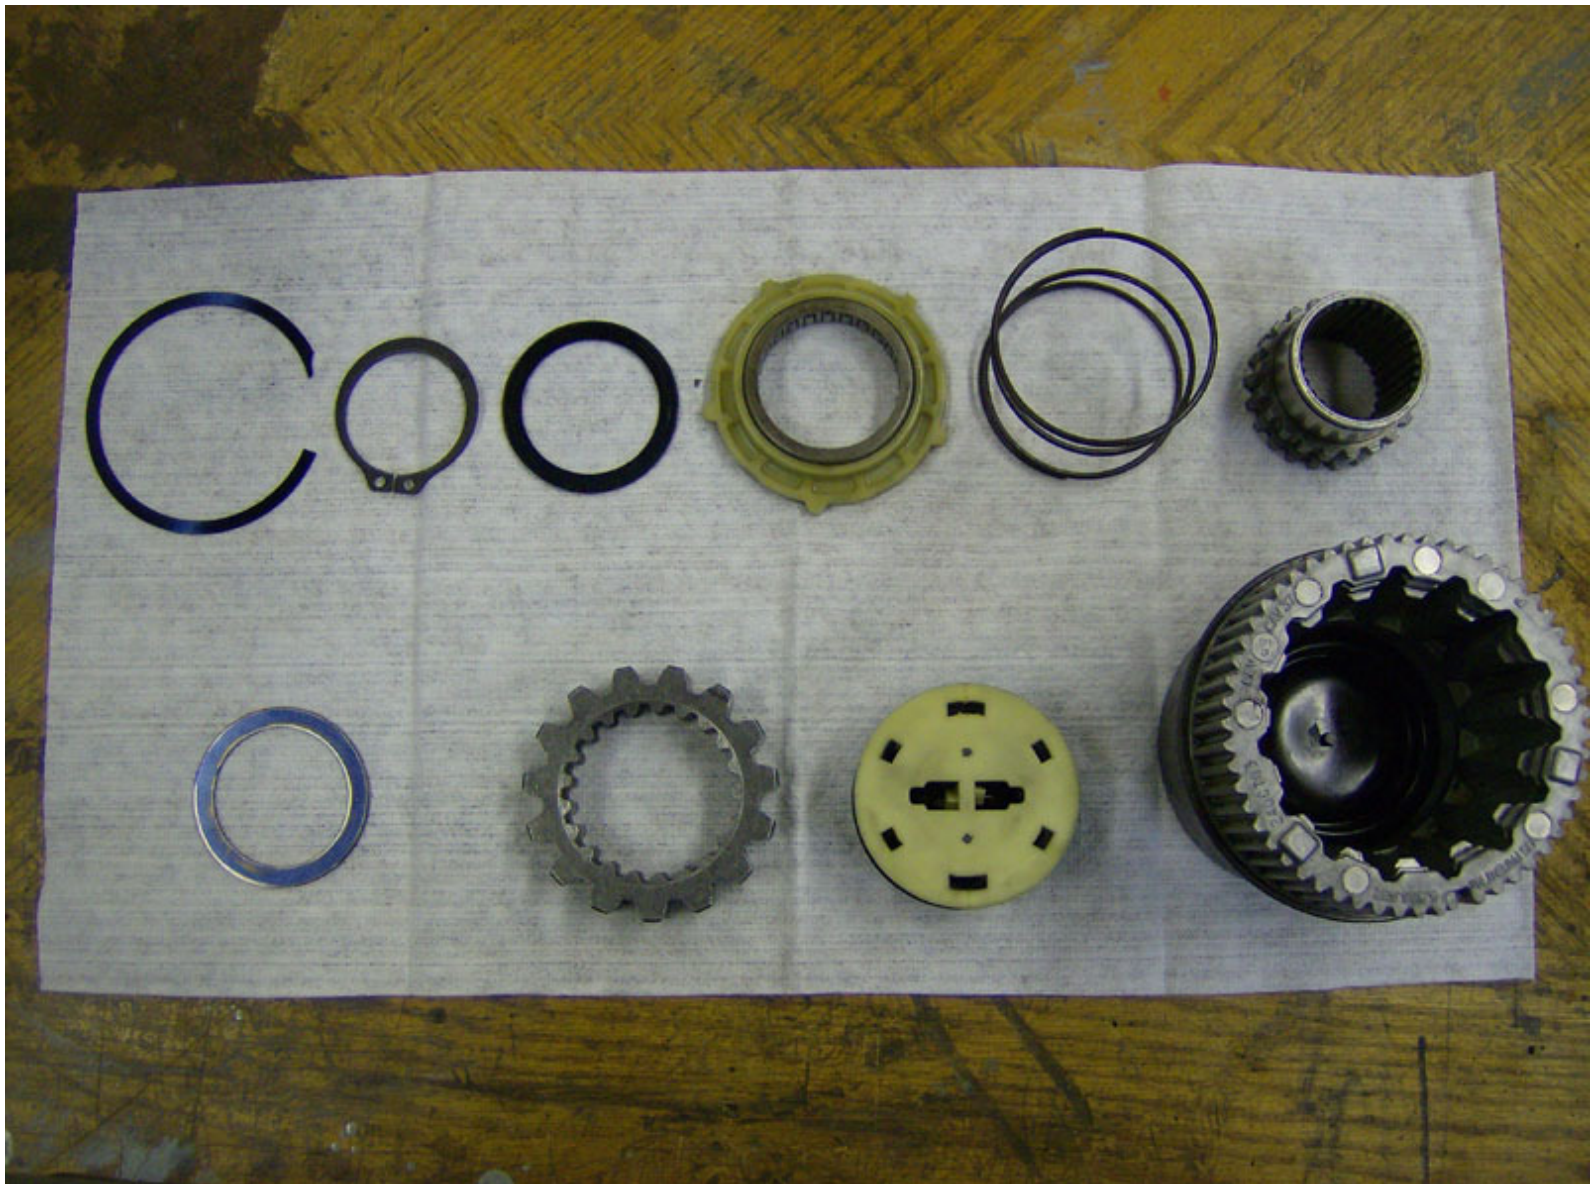
Here's an exploded view of the hubs.
