Ford Super Duty ESOF Hub Service

2004 F250 4x4 XLT Sport Crew Cab

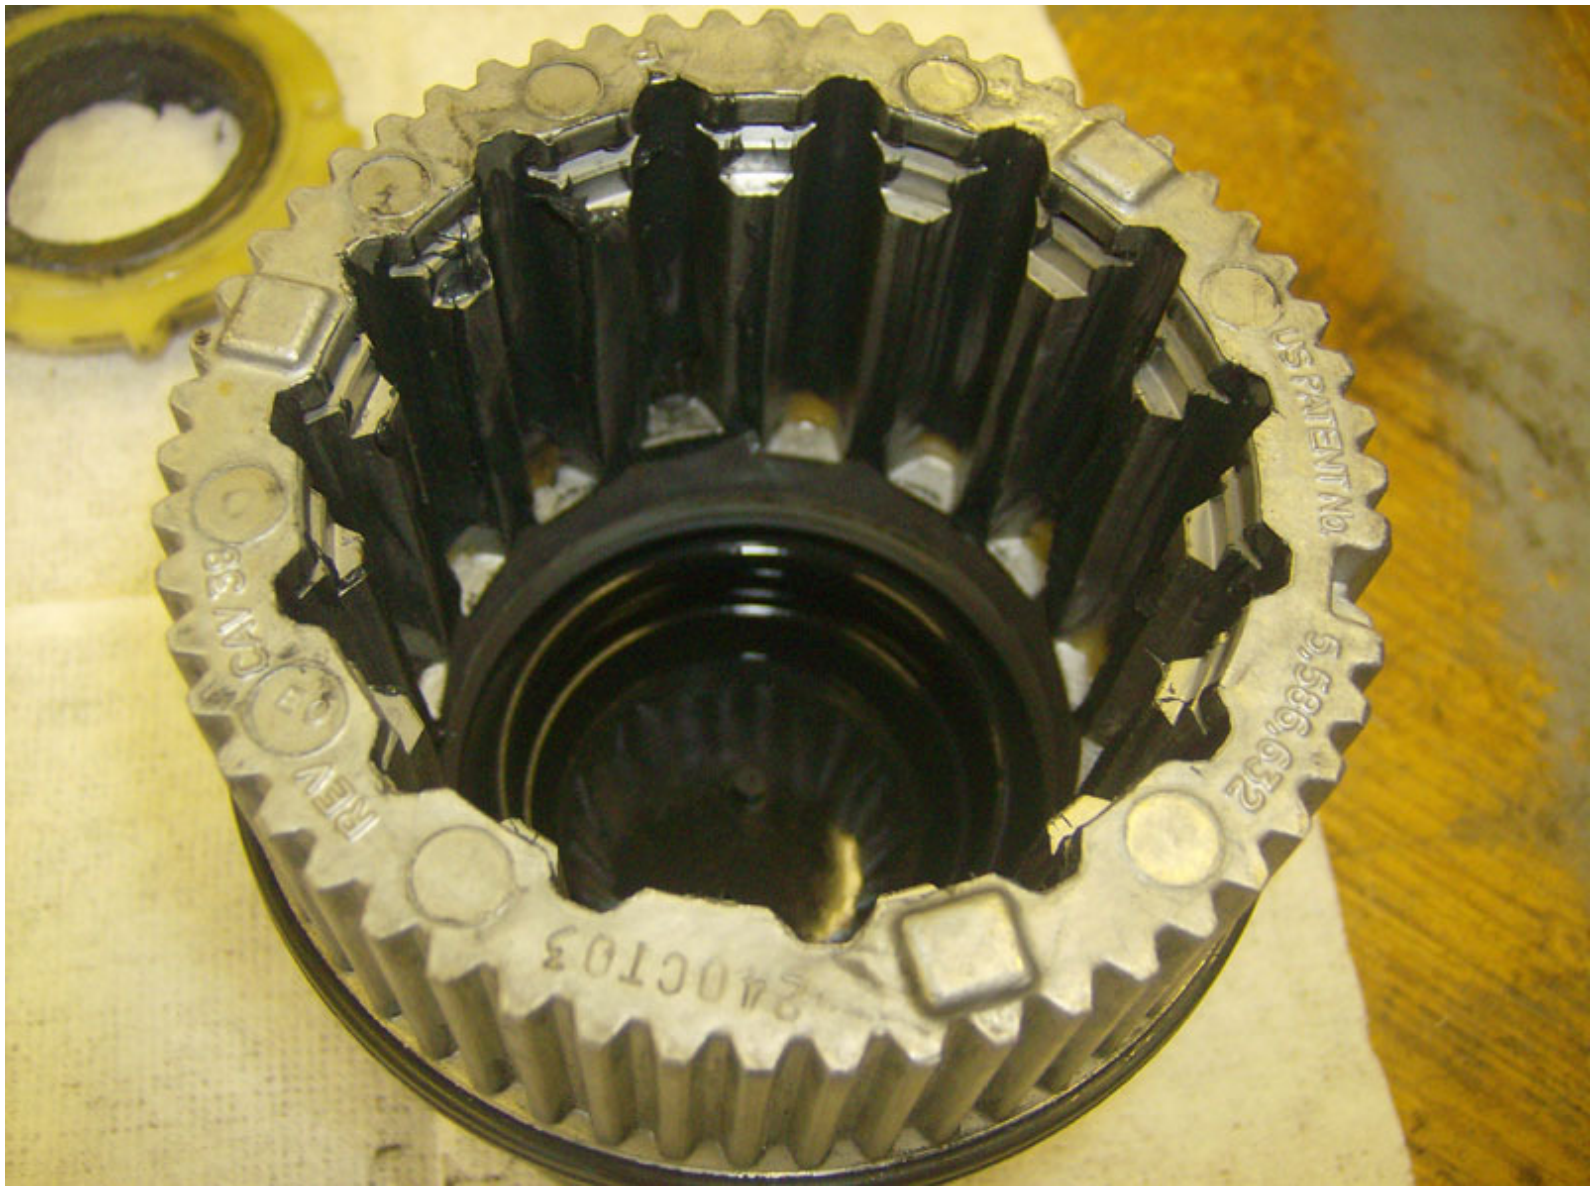
Apply a thin layer of wheel bearing grease to the splines on the inside of the hub.

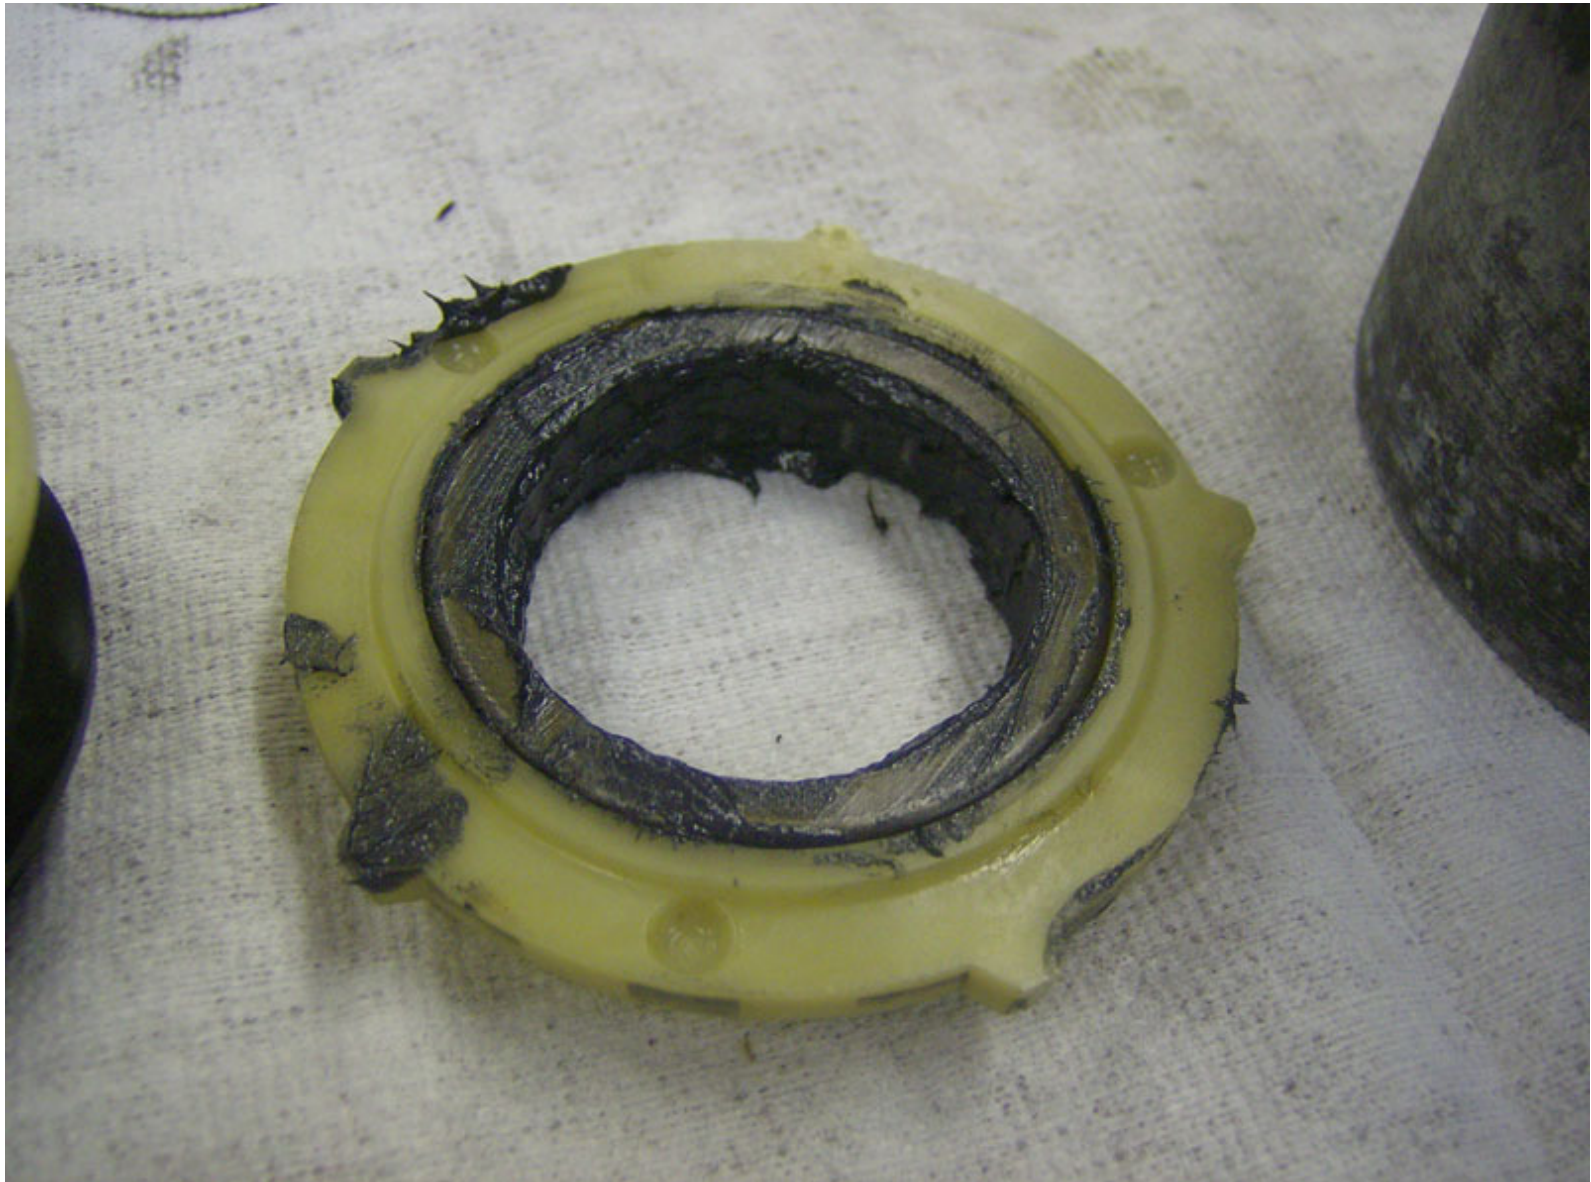
After cleaning all the old grease out of the bearing (with the CRC QD cleaner), repack it with wheel bearing grease. Note the orientation of the bearing. The side with the writing on it faces up in the picture below.

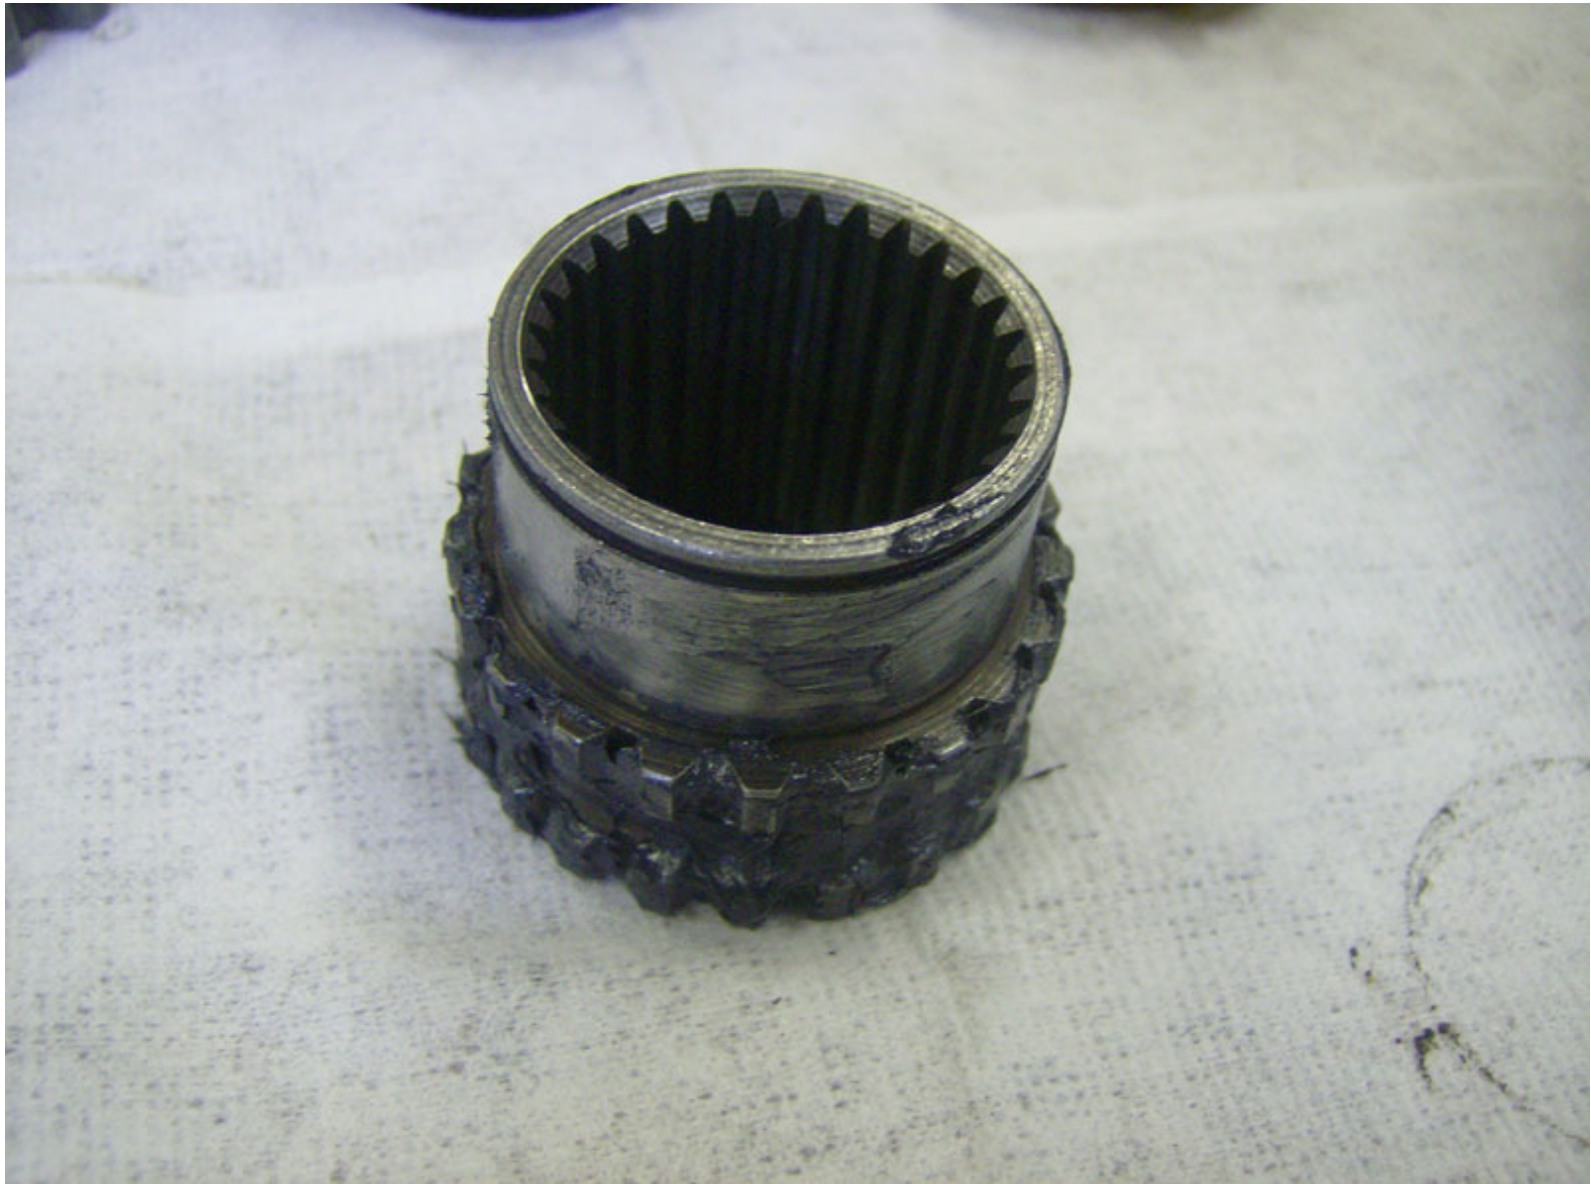
Apply some bearing grease to the external teeth on this gear.

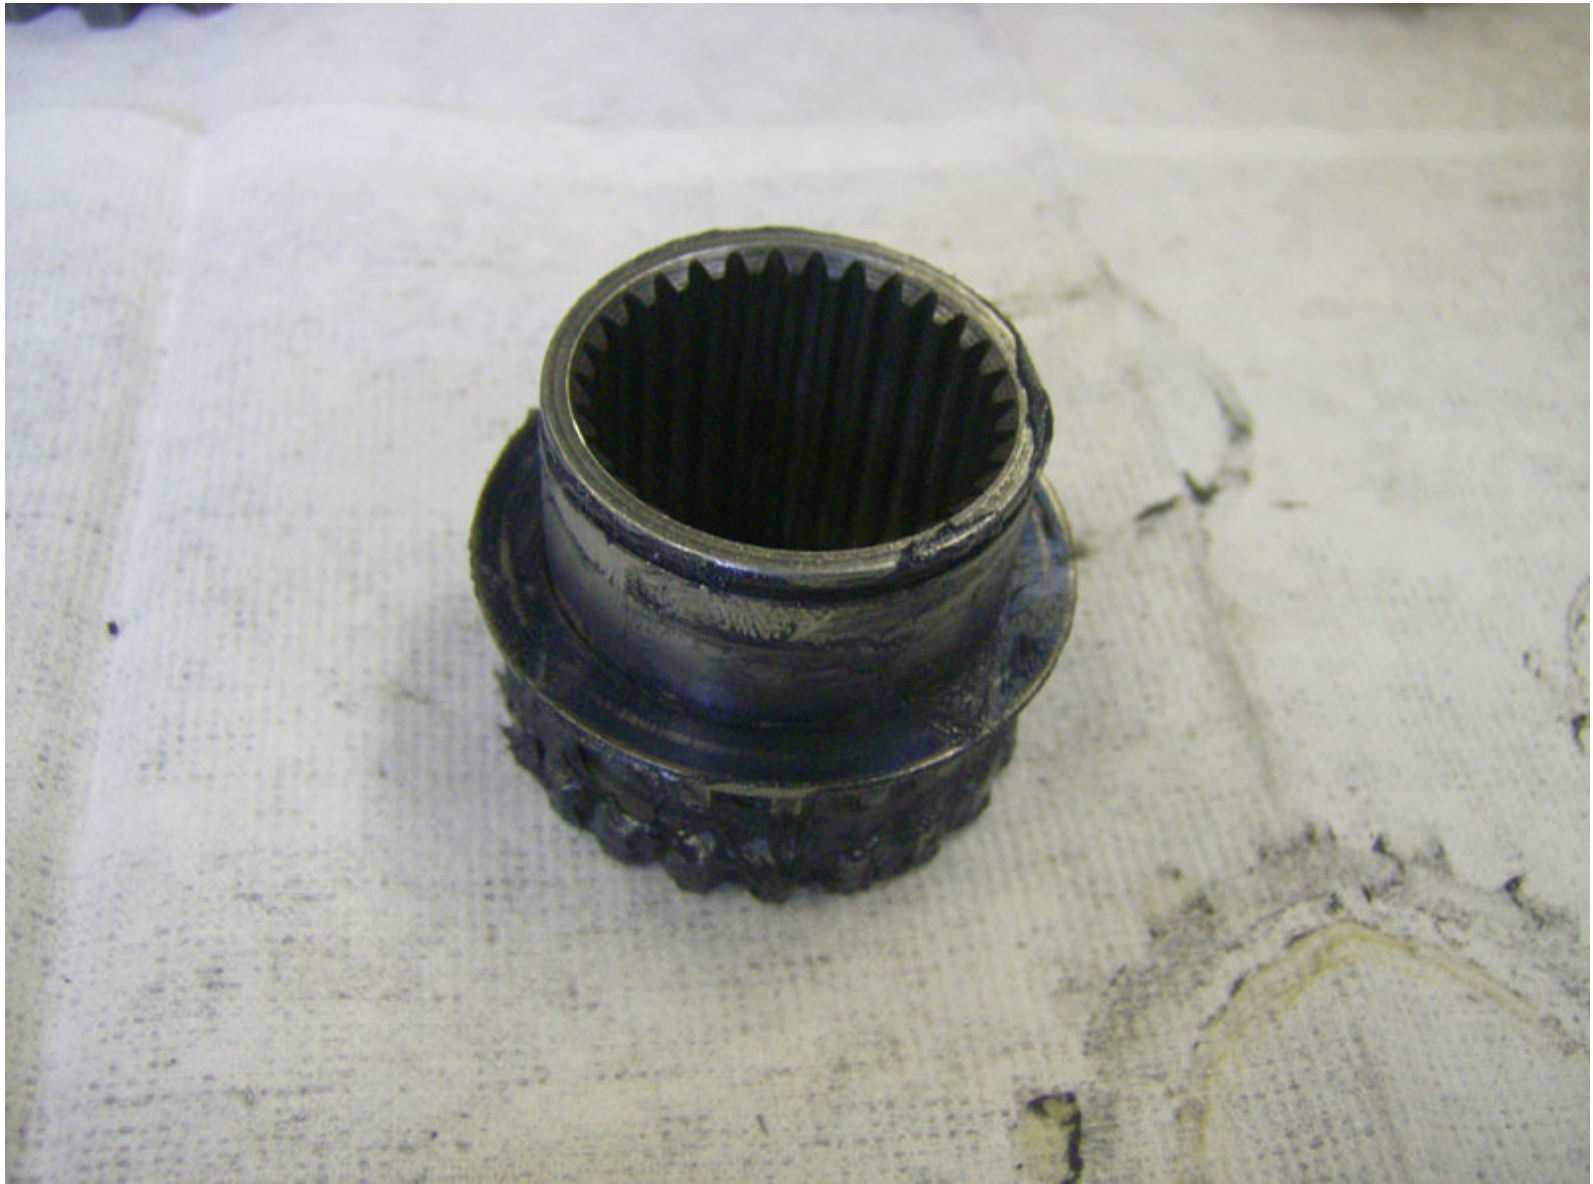
Install the first thrust washer on the gear.

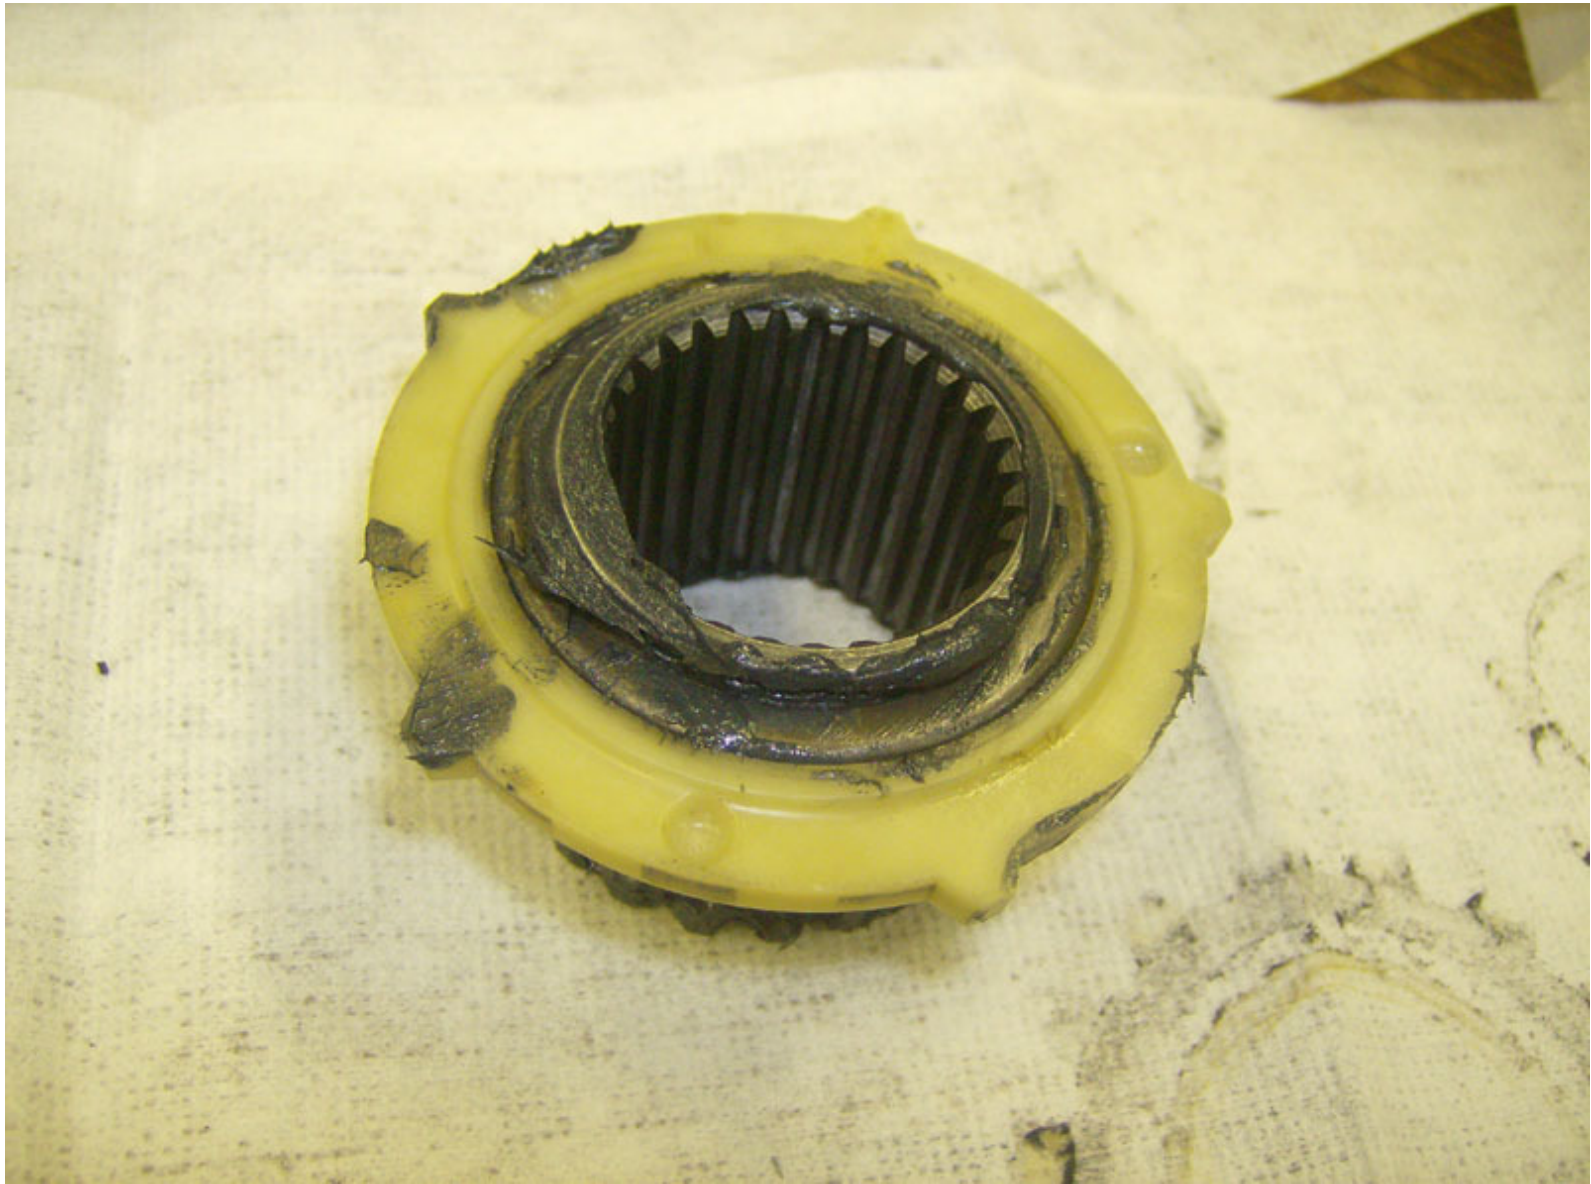
Place the bearing and plastic housing on the gear next.

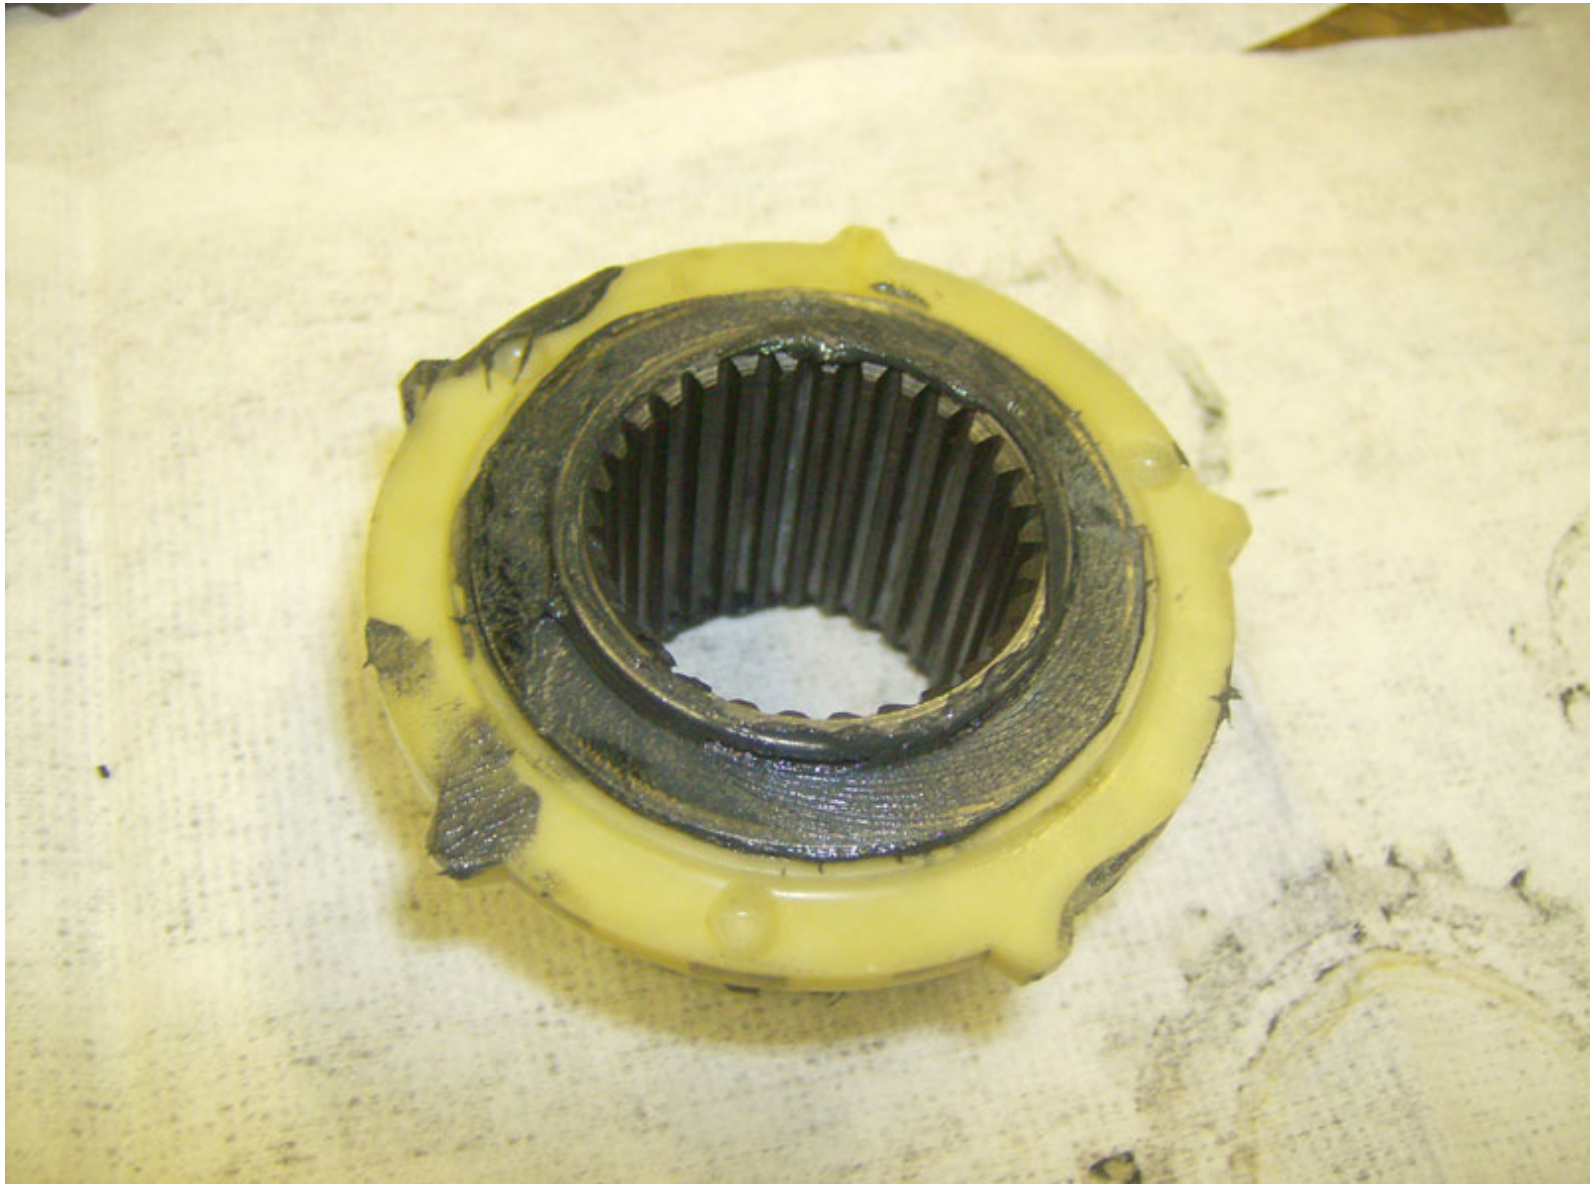
Install the other thrust washer.

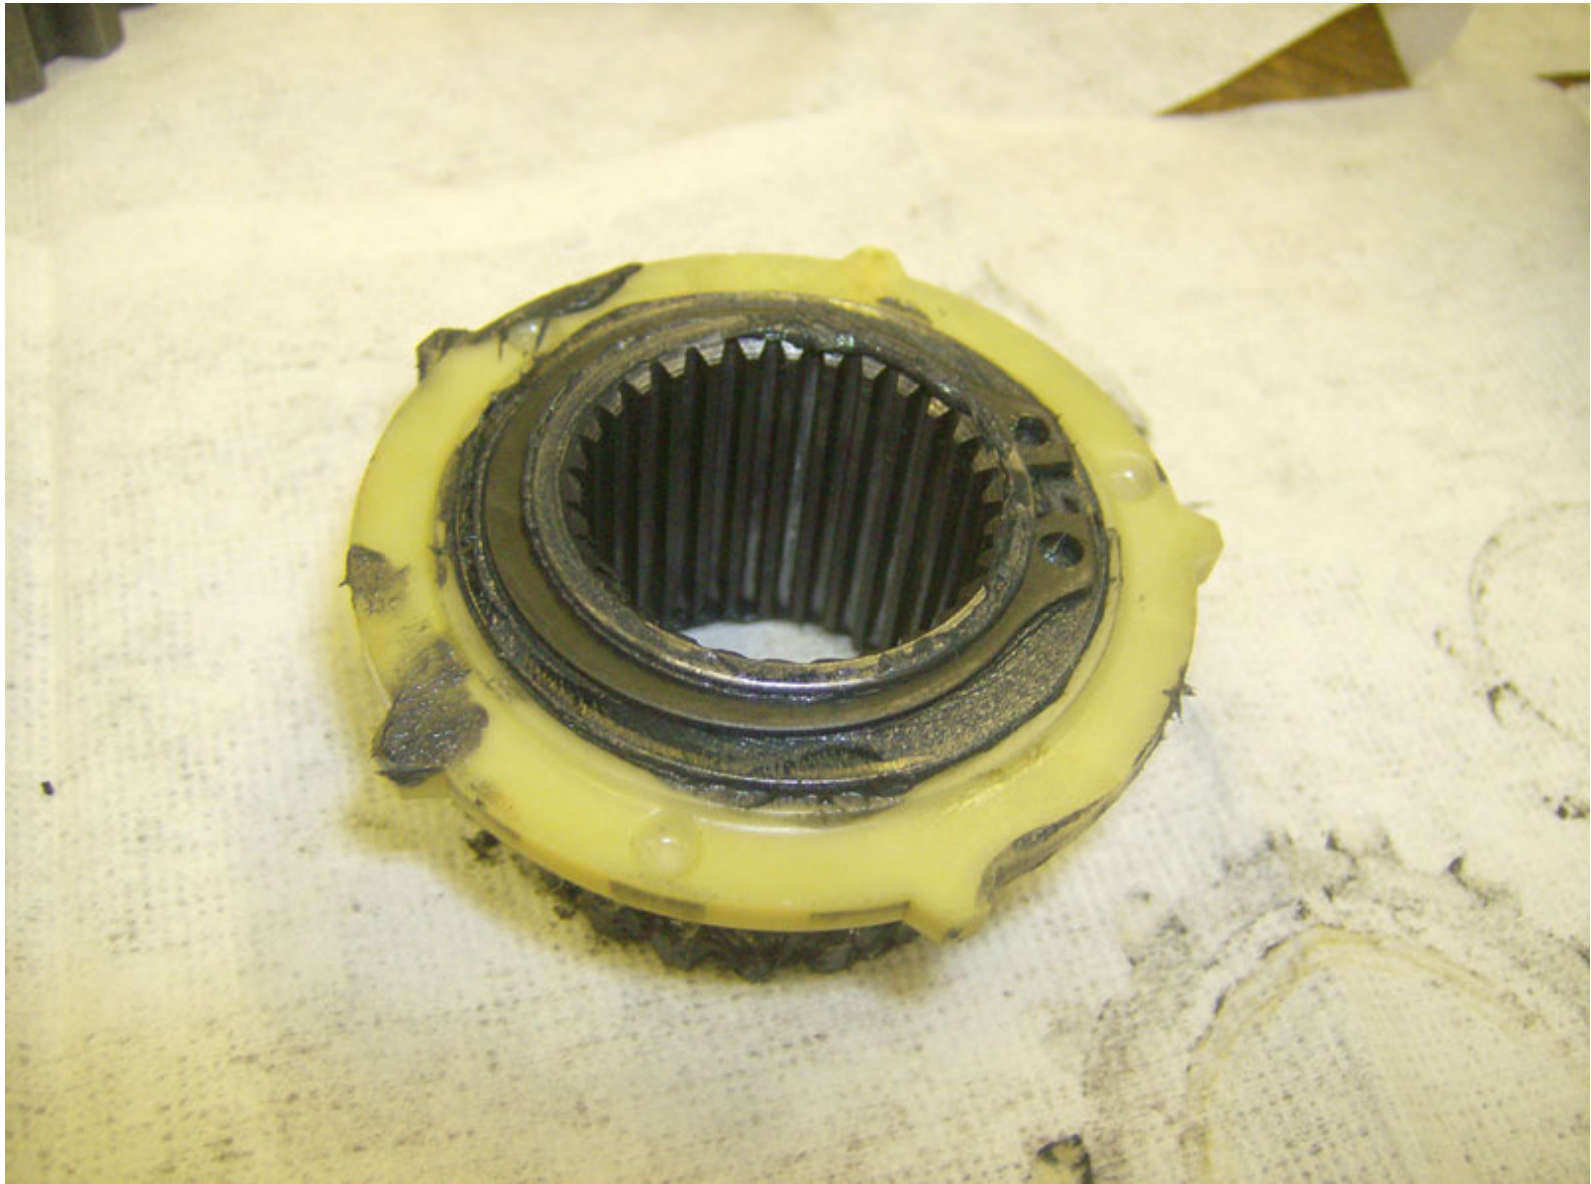
Now install the snap ring to hold it all together.

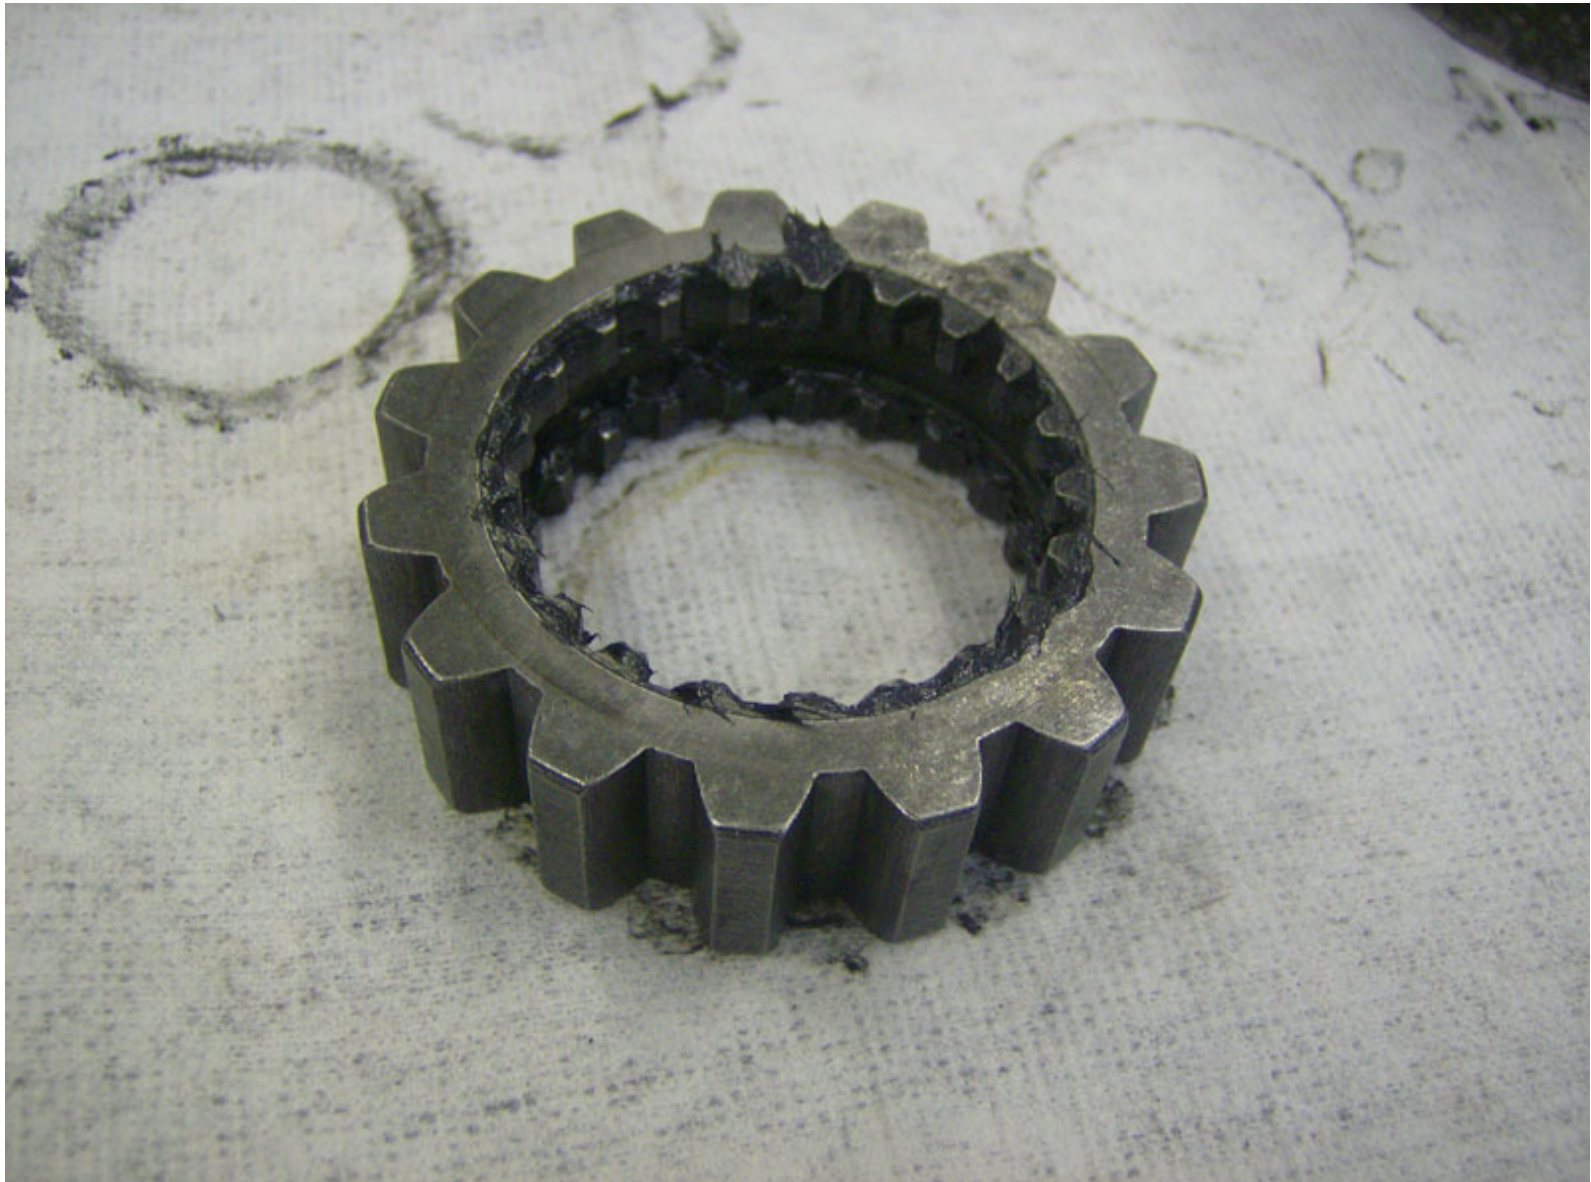
Next, apply a small amount of grease to the internal teeth of this gear.

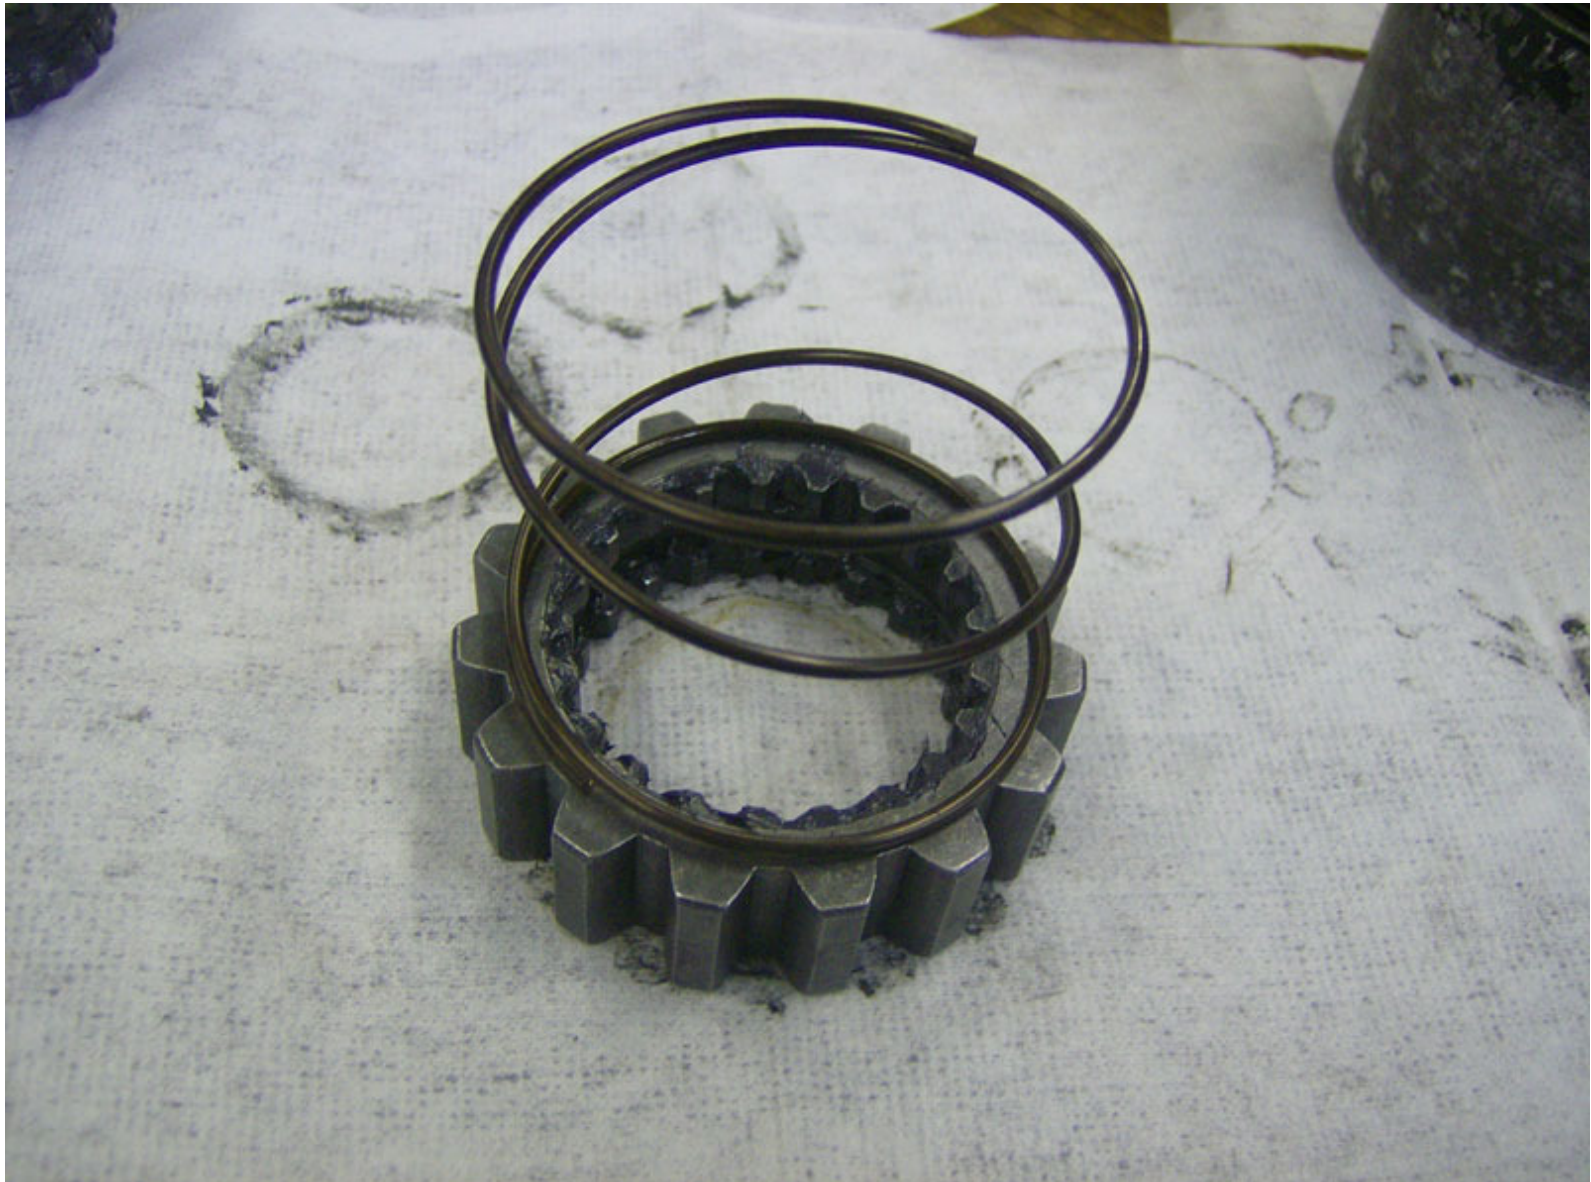
Place the spring on top of the gear

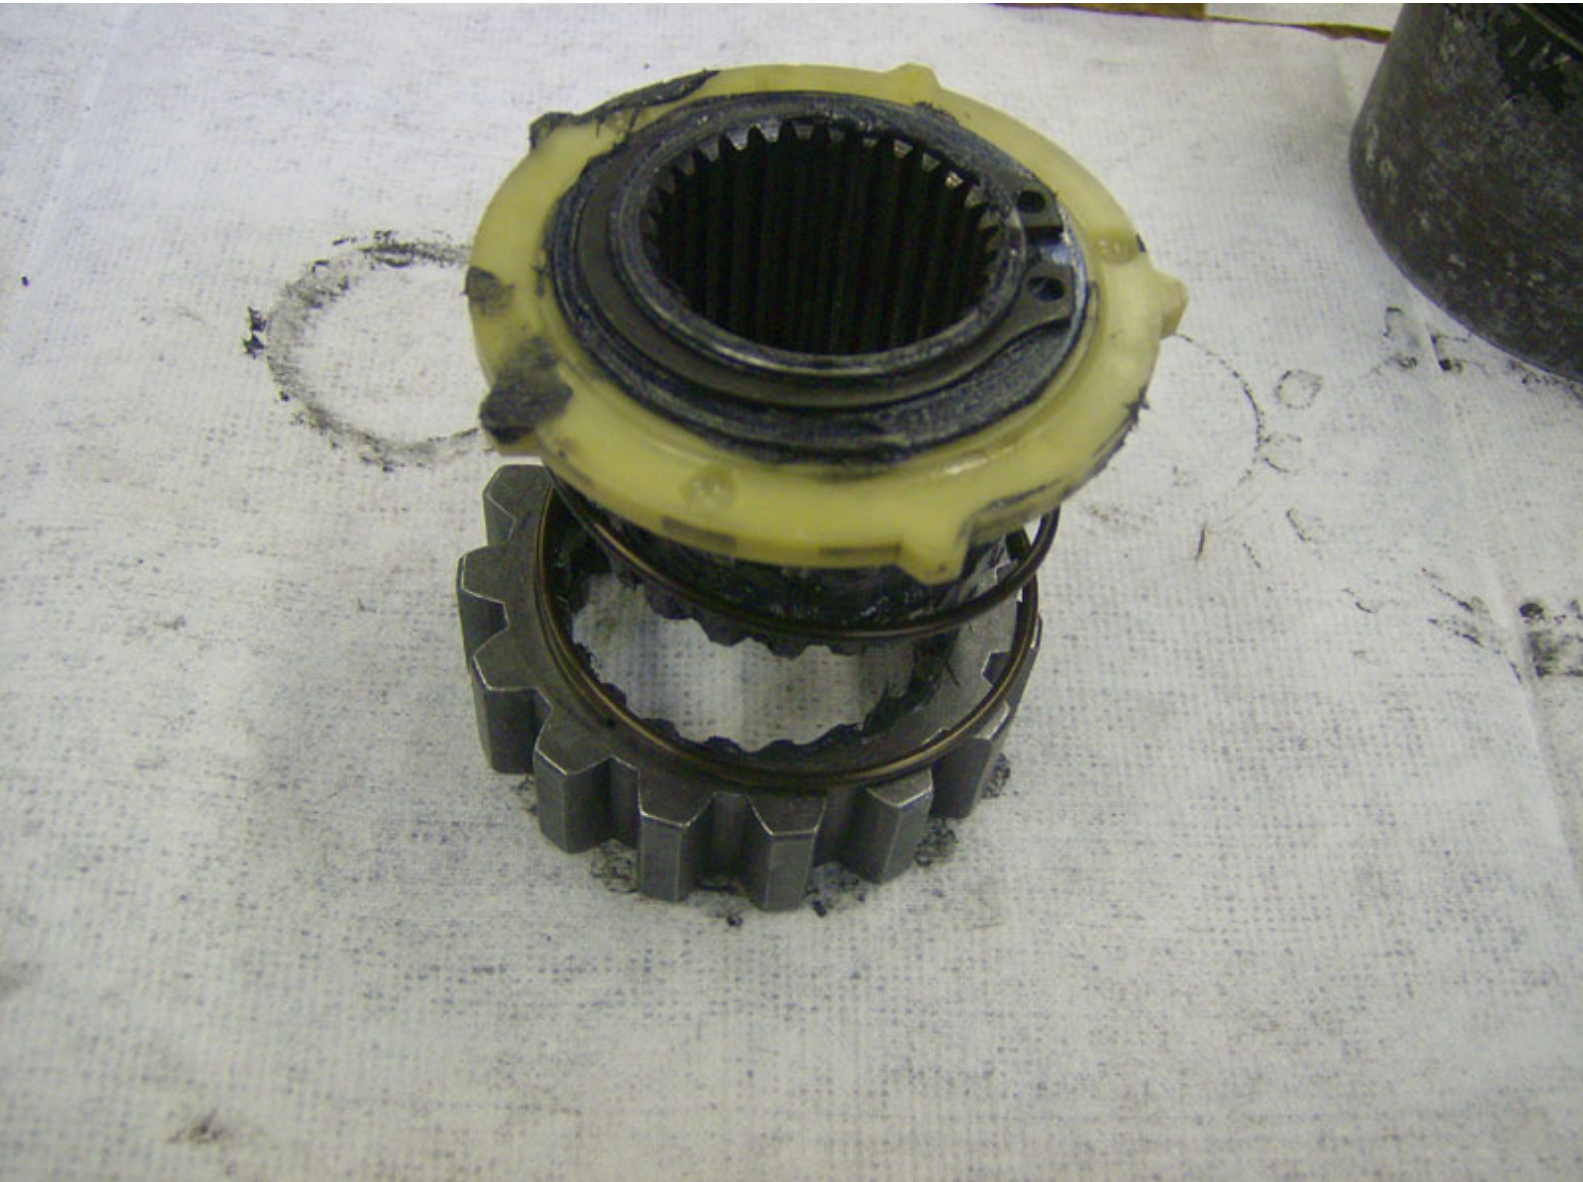
Place the previously installed gear assembly on top of the spring

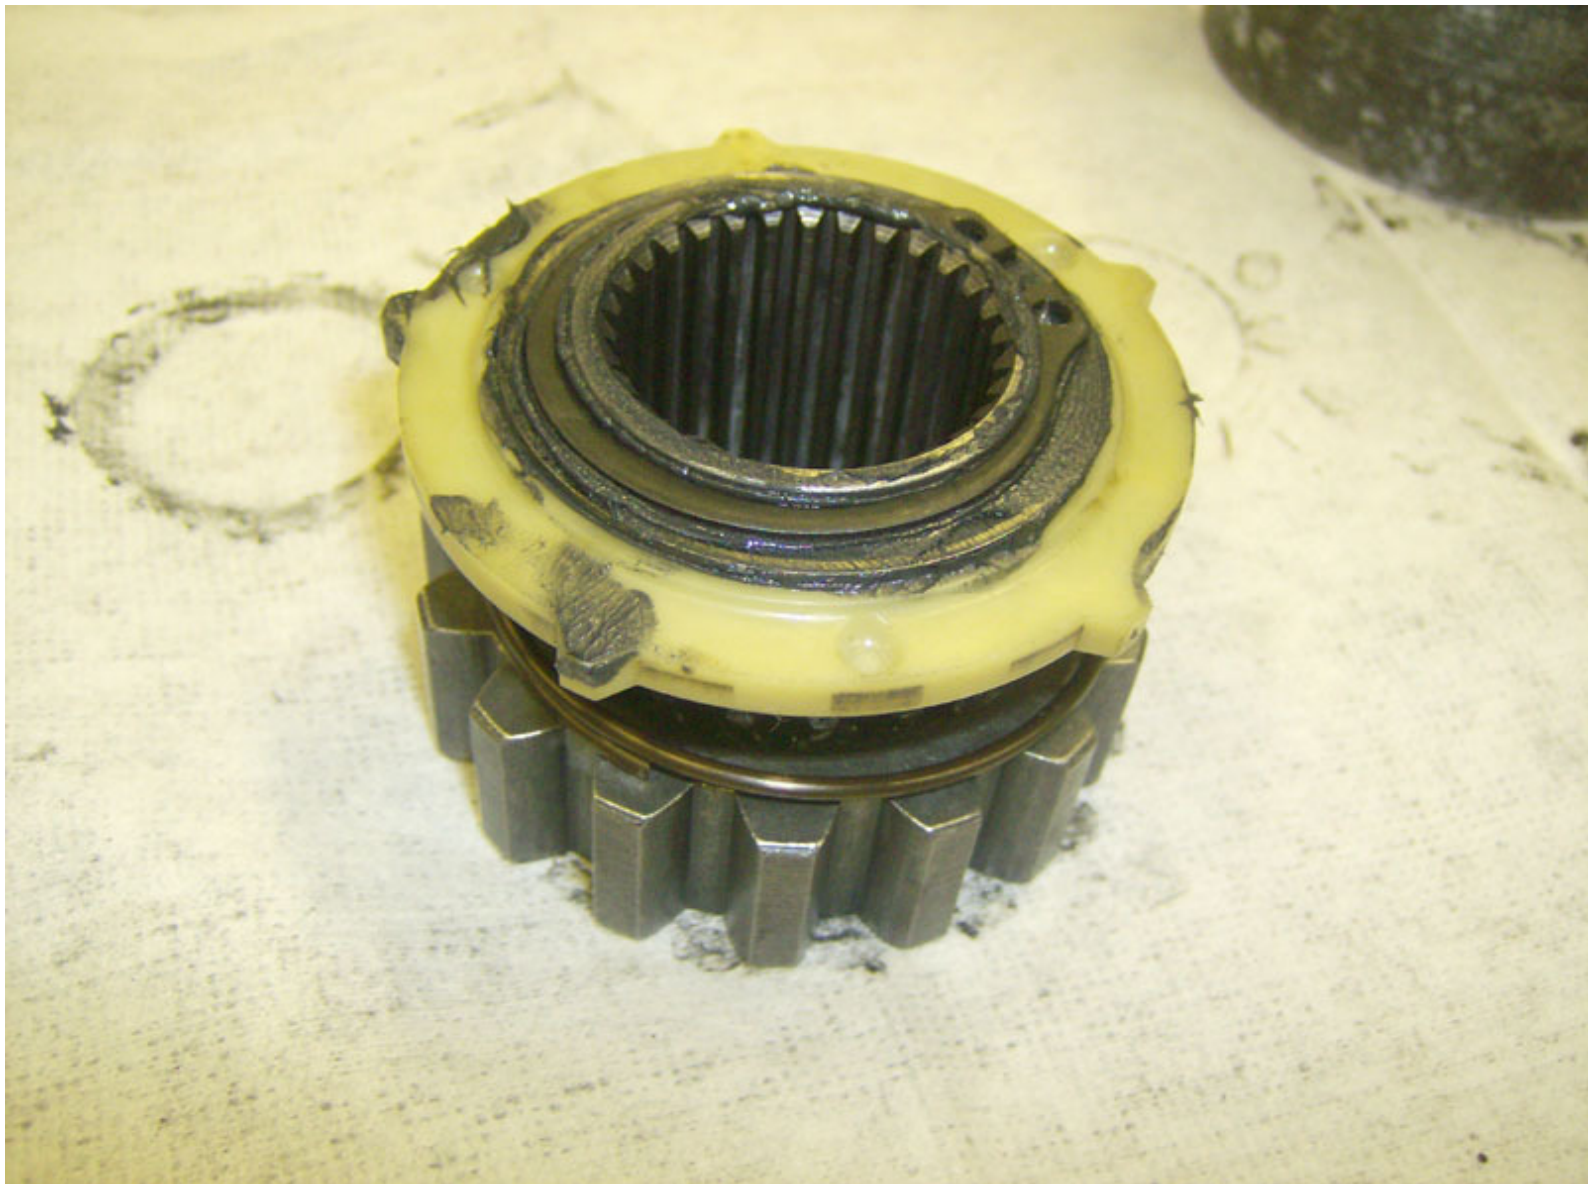
Now you can compress the spring, align the gear teeth and insert the top gear partially through the bottom gear. Once you clear the upper set of teeth, give the upper assembly a slight turn to lock it all together.
