Ford Super Duty ESOF Hub Service

2004 F250 4x4 XLT Sport Crew Cab

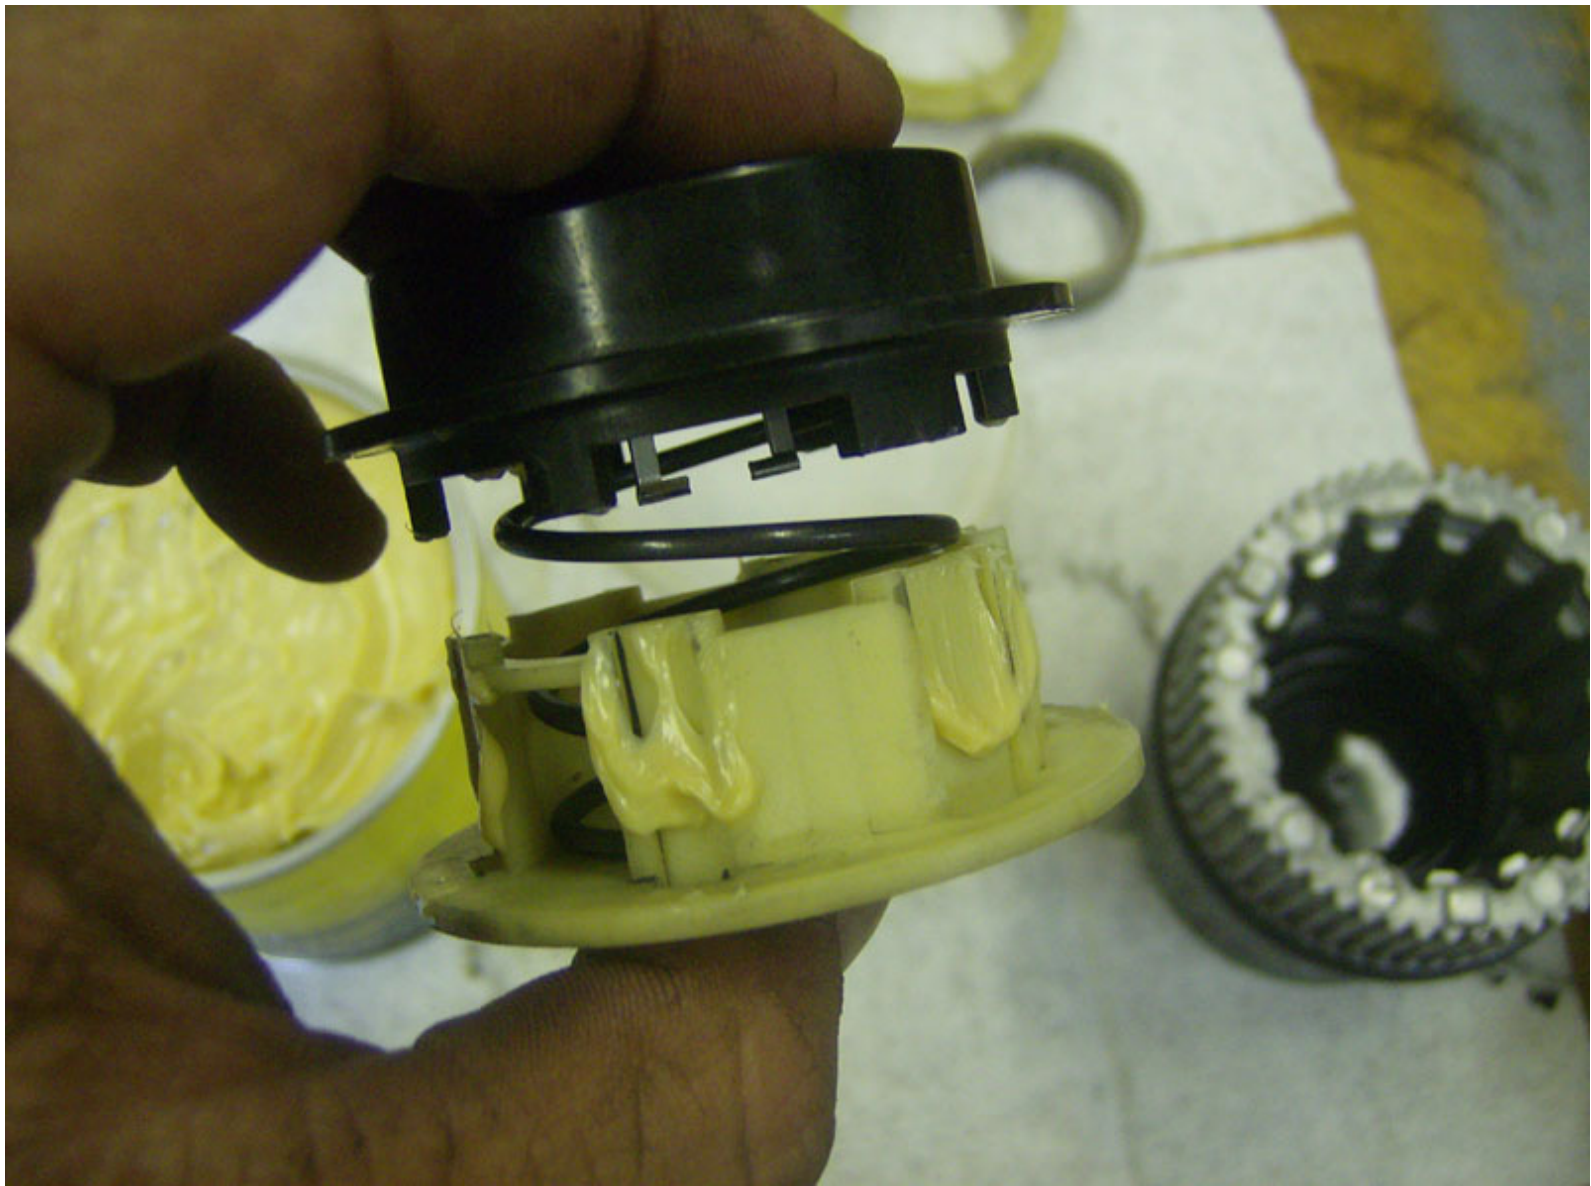
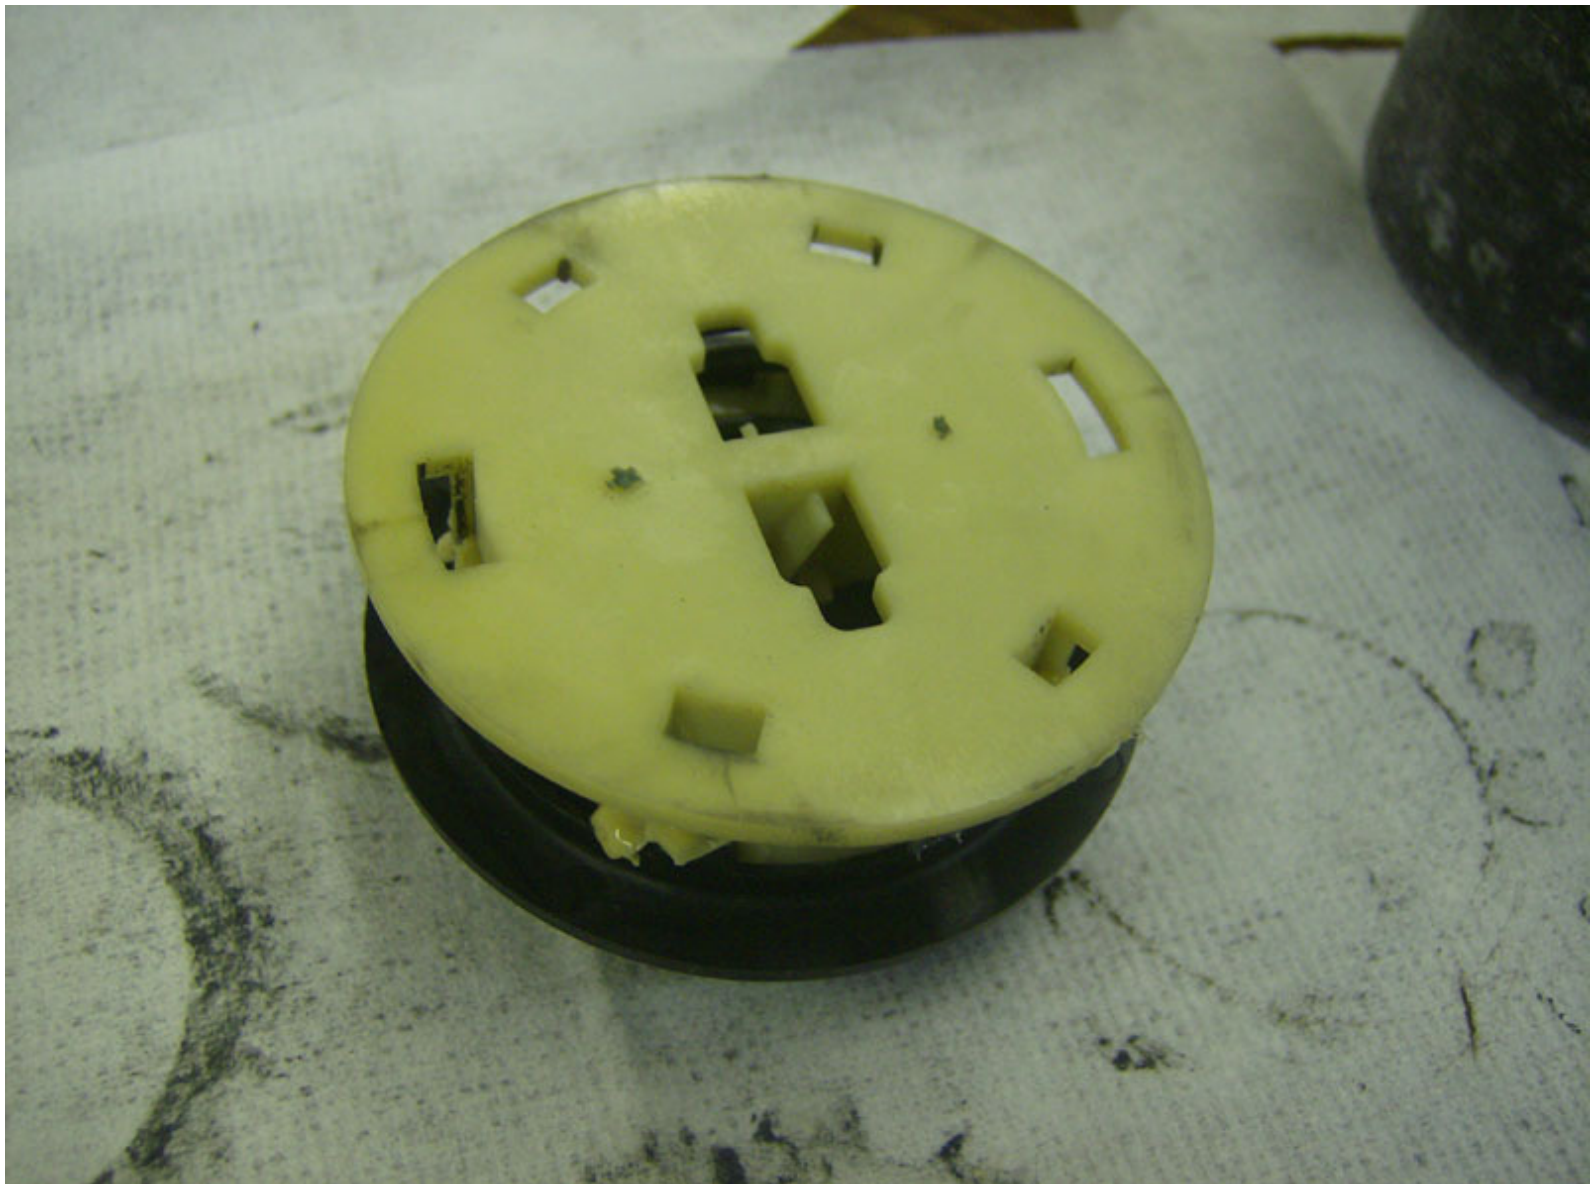
This pic shows how the "plastic assembly in the bottom of the hub" goes back together. Apply a little white grease on the areas where the pieces slide together. You can see how the metal tabs snap to the plastic housing, align the pieces and it will snap back together.

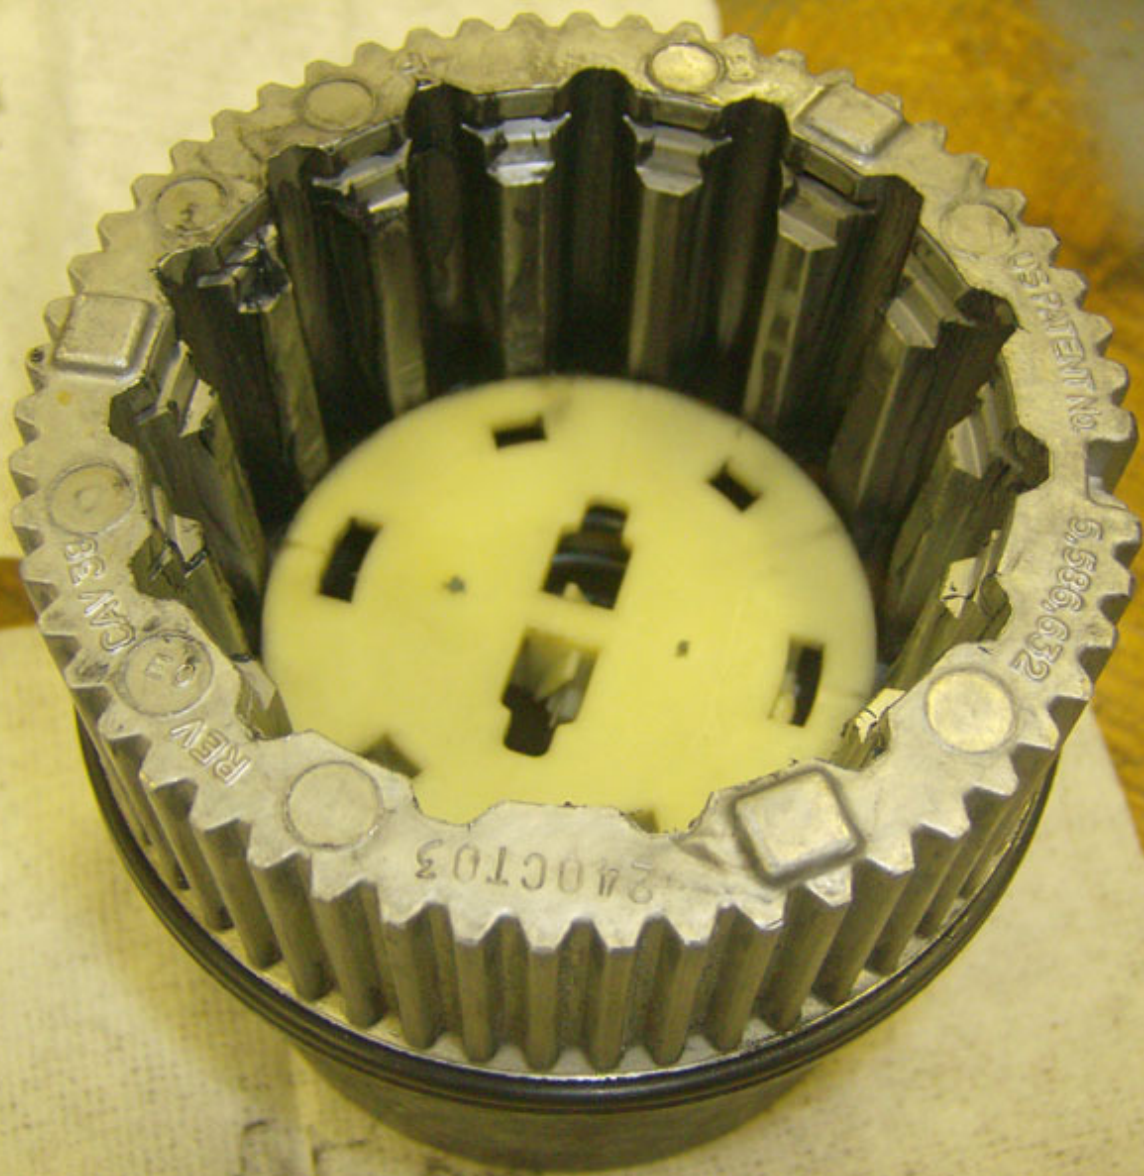
Insert this assembly into the bottom of the hub

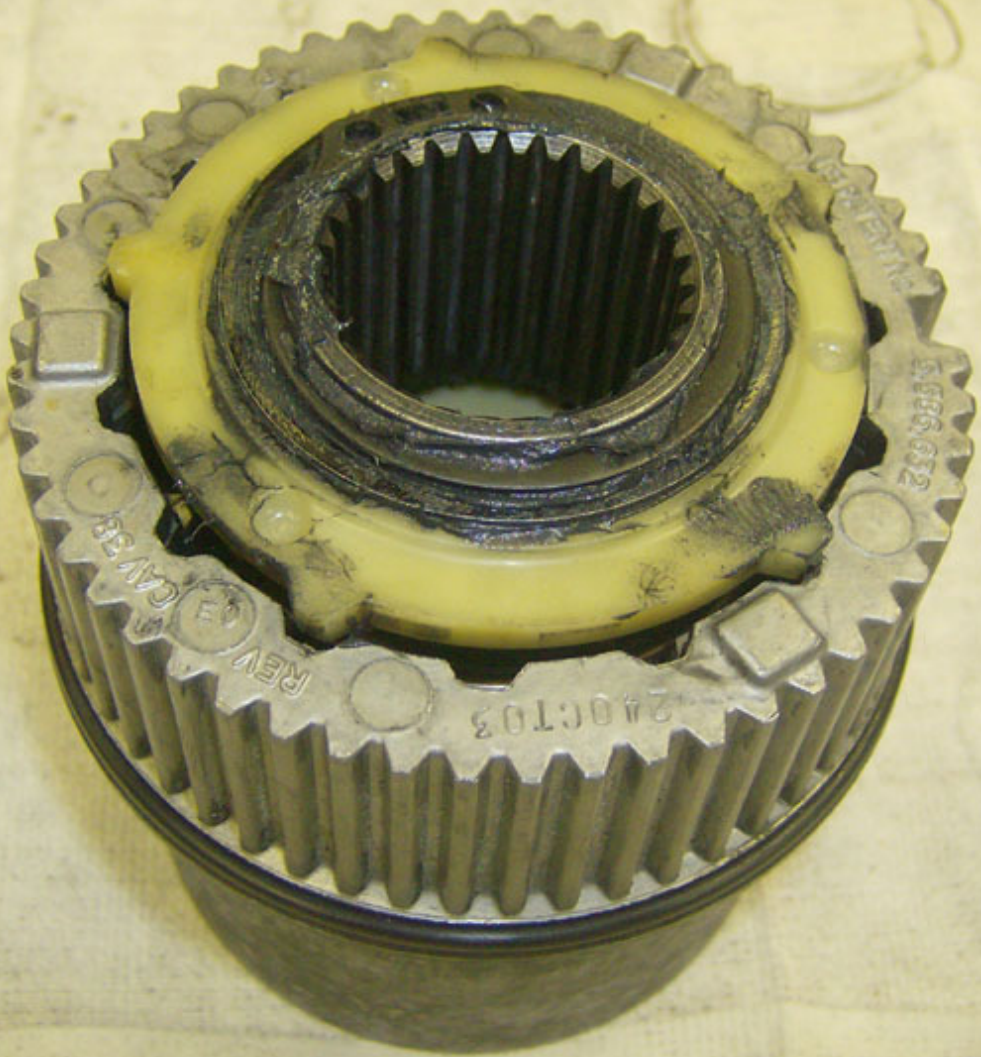
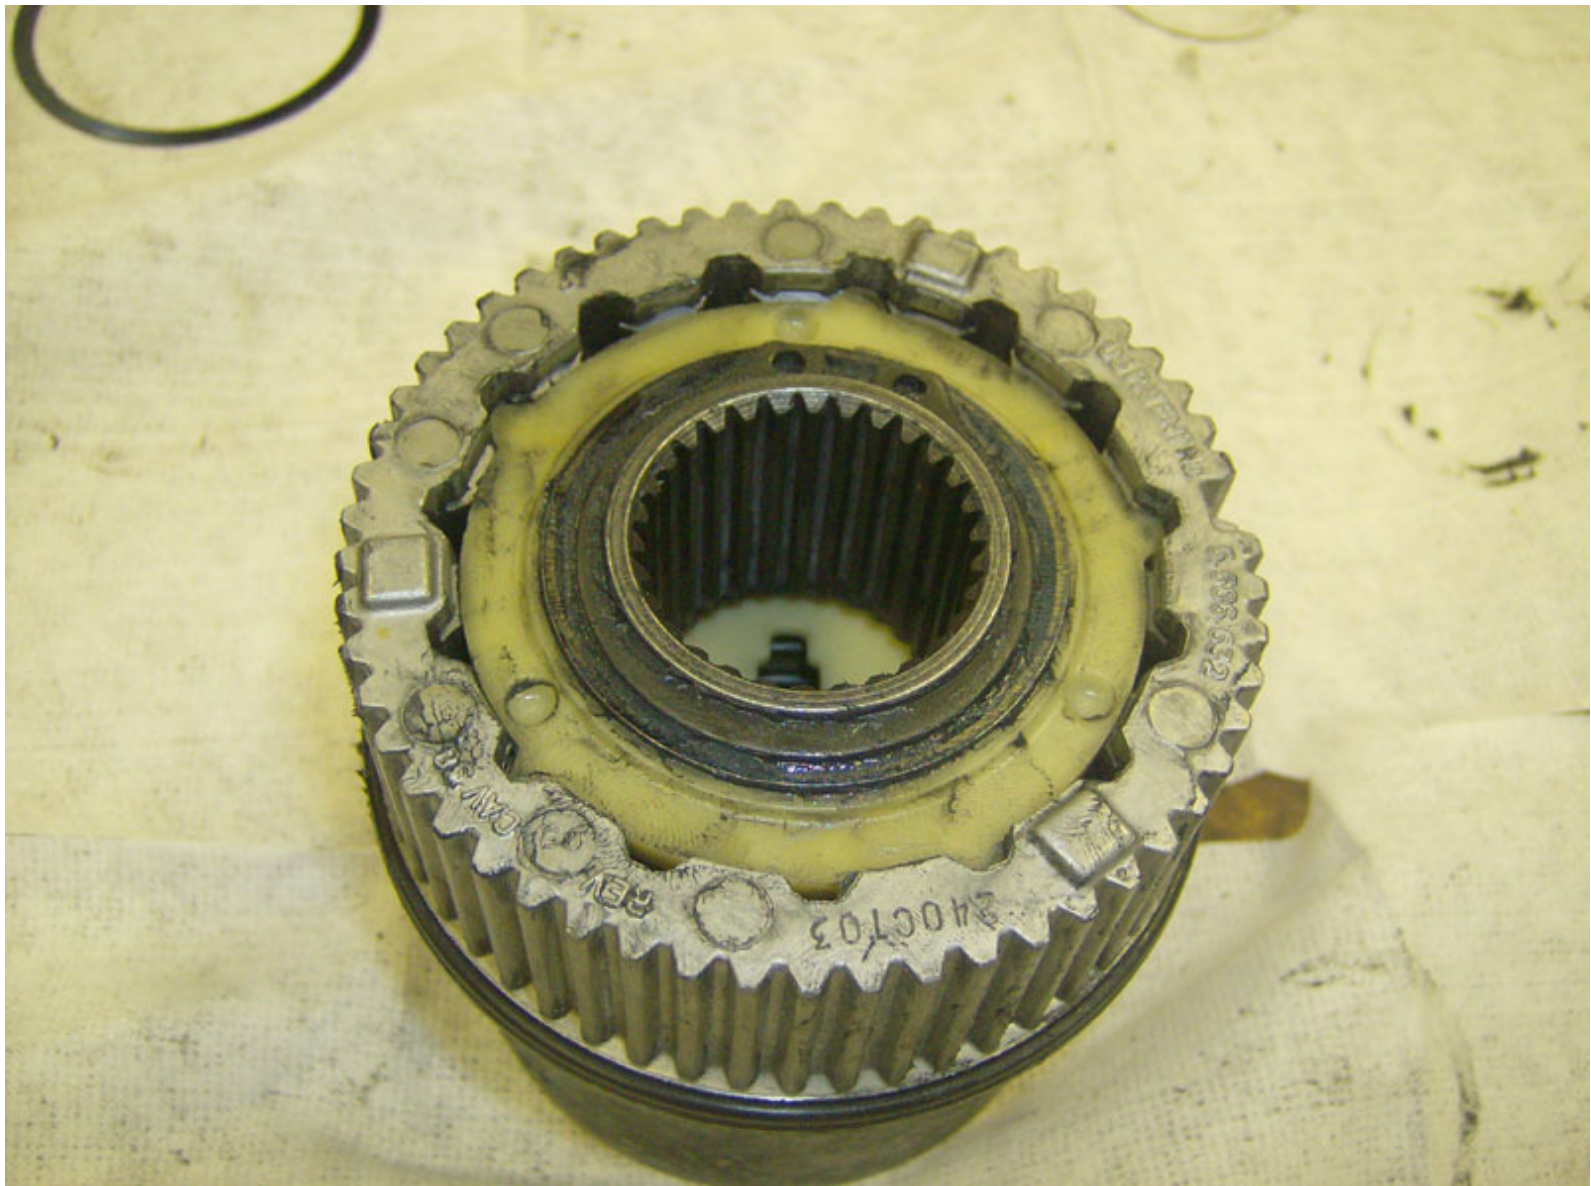
Install the entire gear assembly (upper gear assy, spring, lower gear) into the hub. It will slide in far enough to allow the large clip ring to seat into its groove.

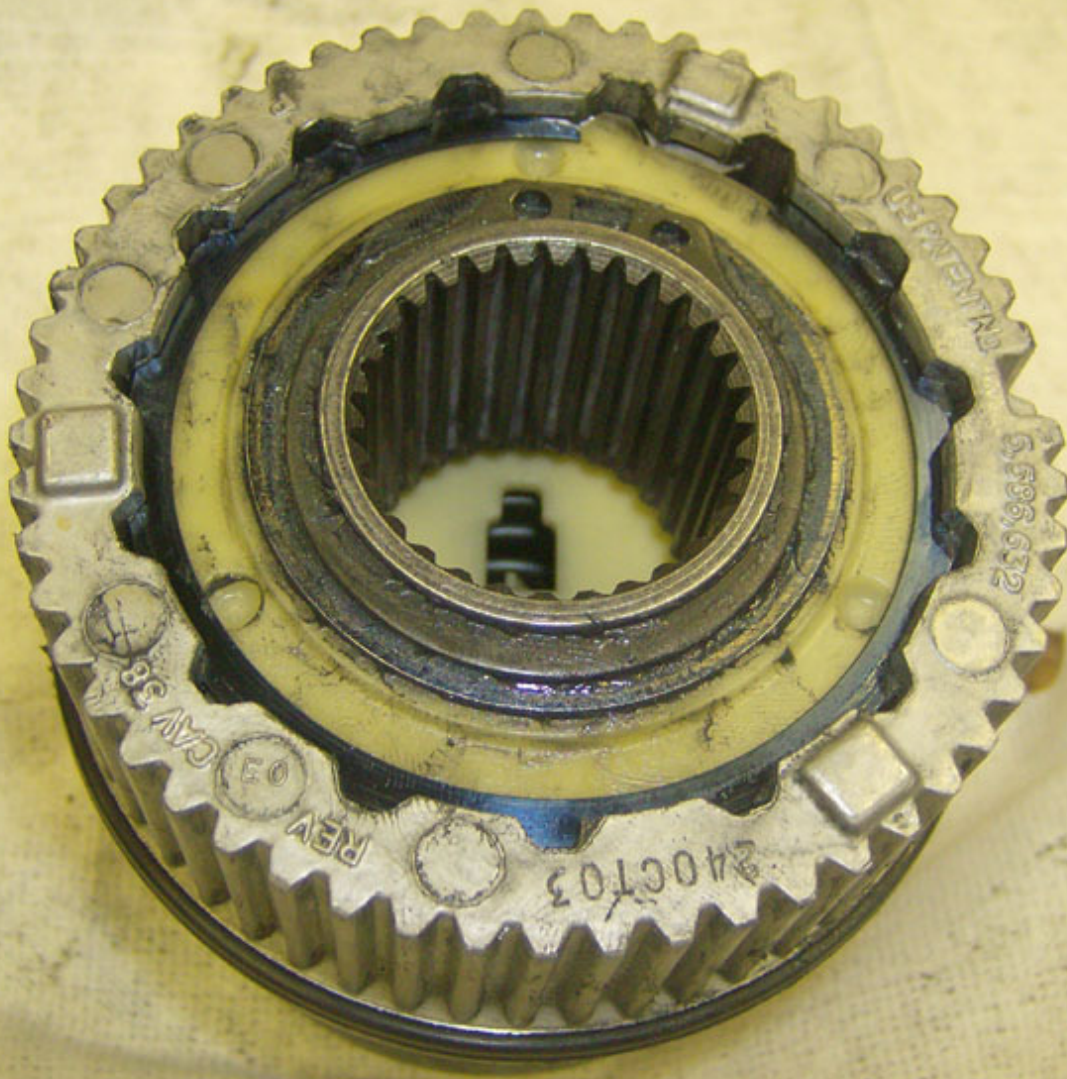
Reinstall the large clip ring

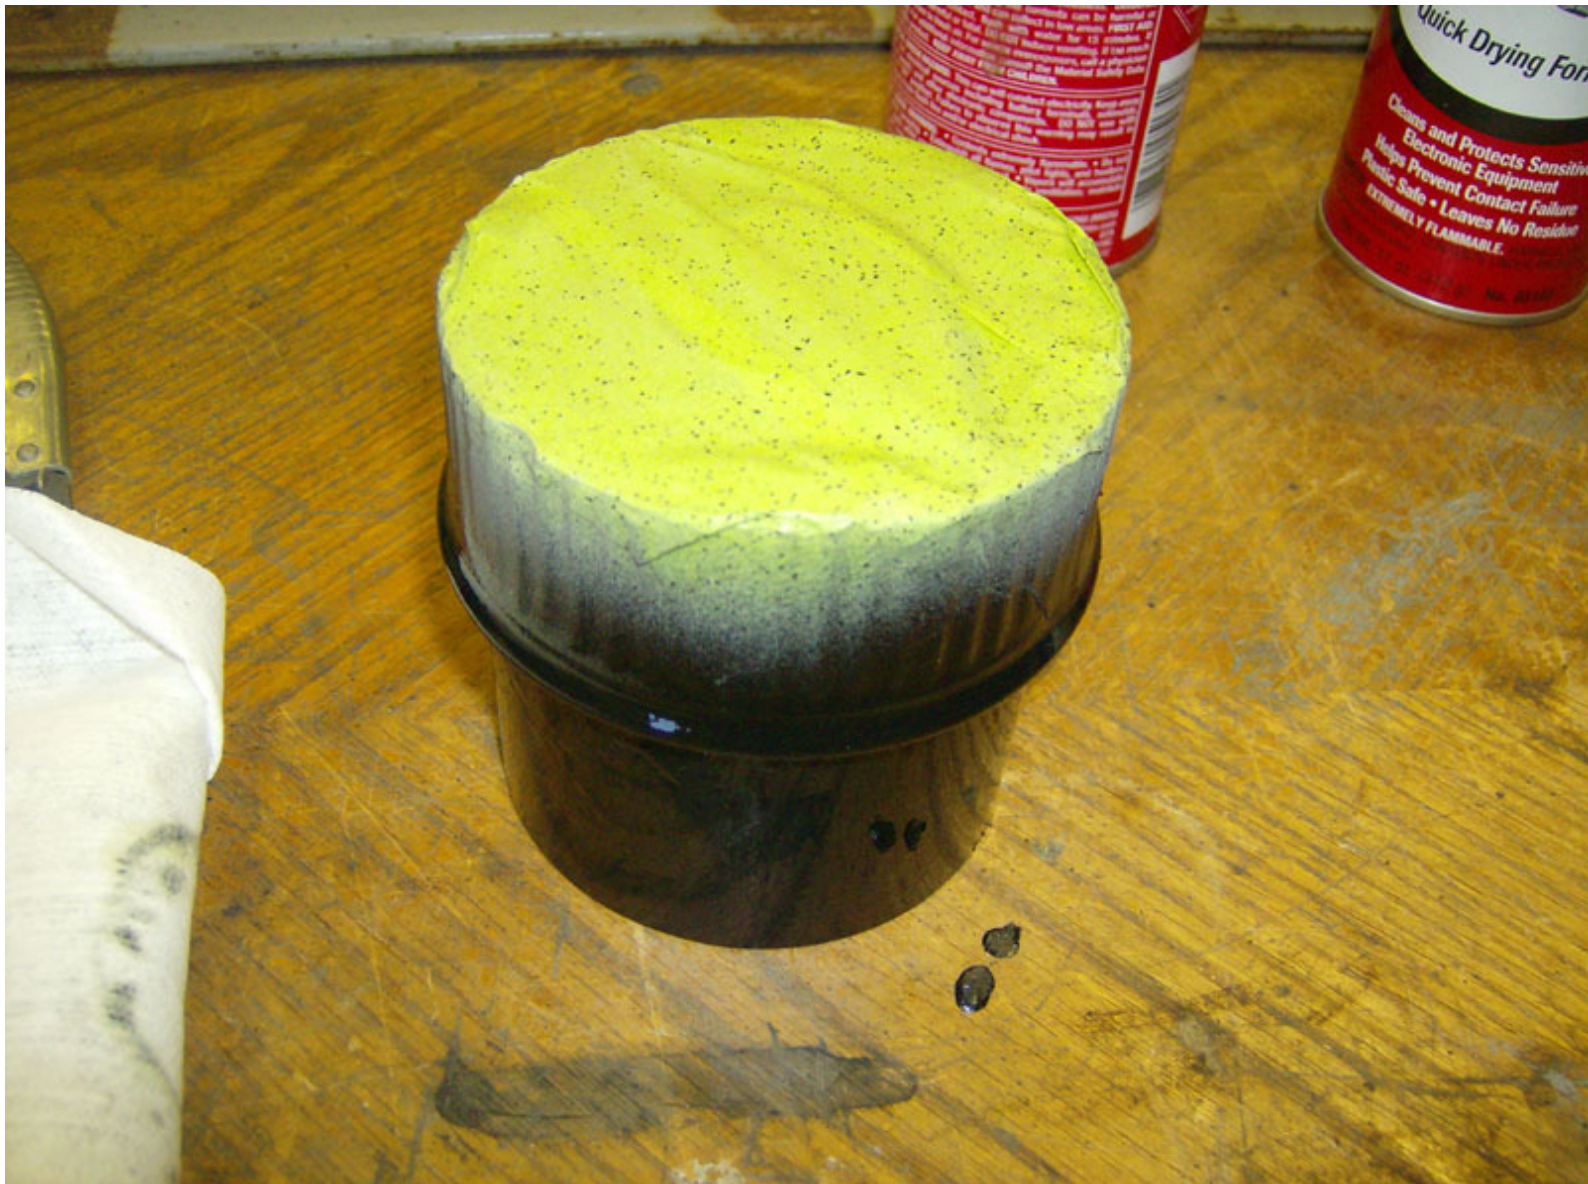
Now that the reassembly is complete, I taped off the business end and primed and painted the hub.

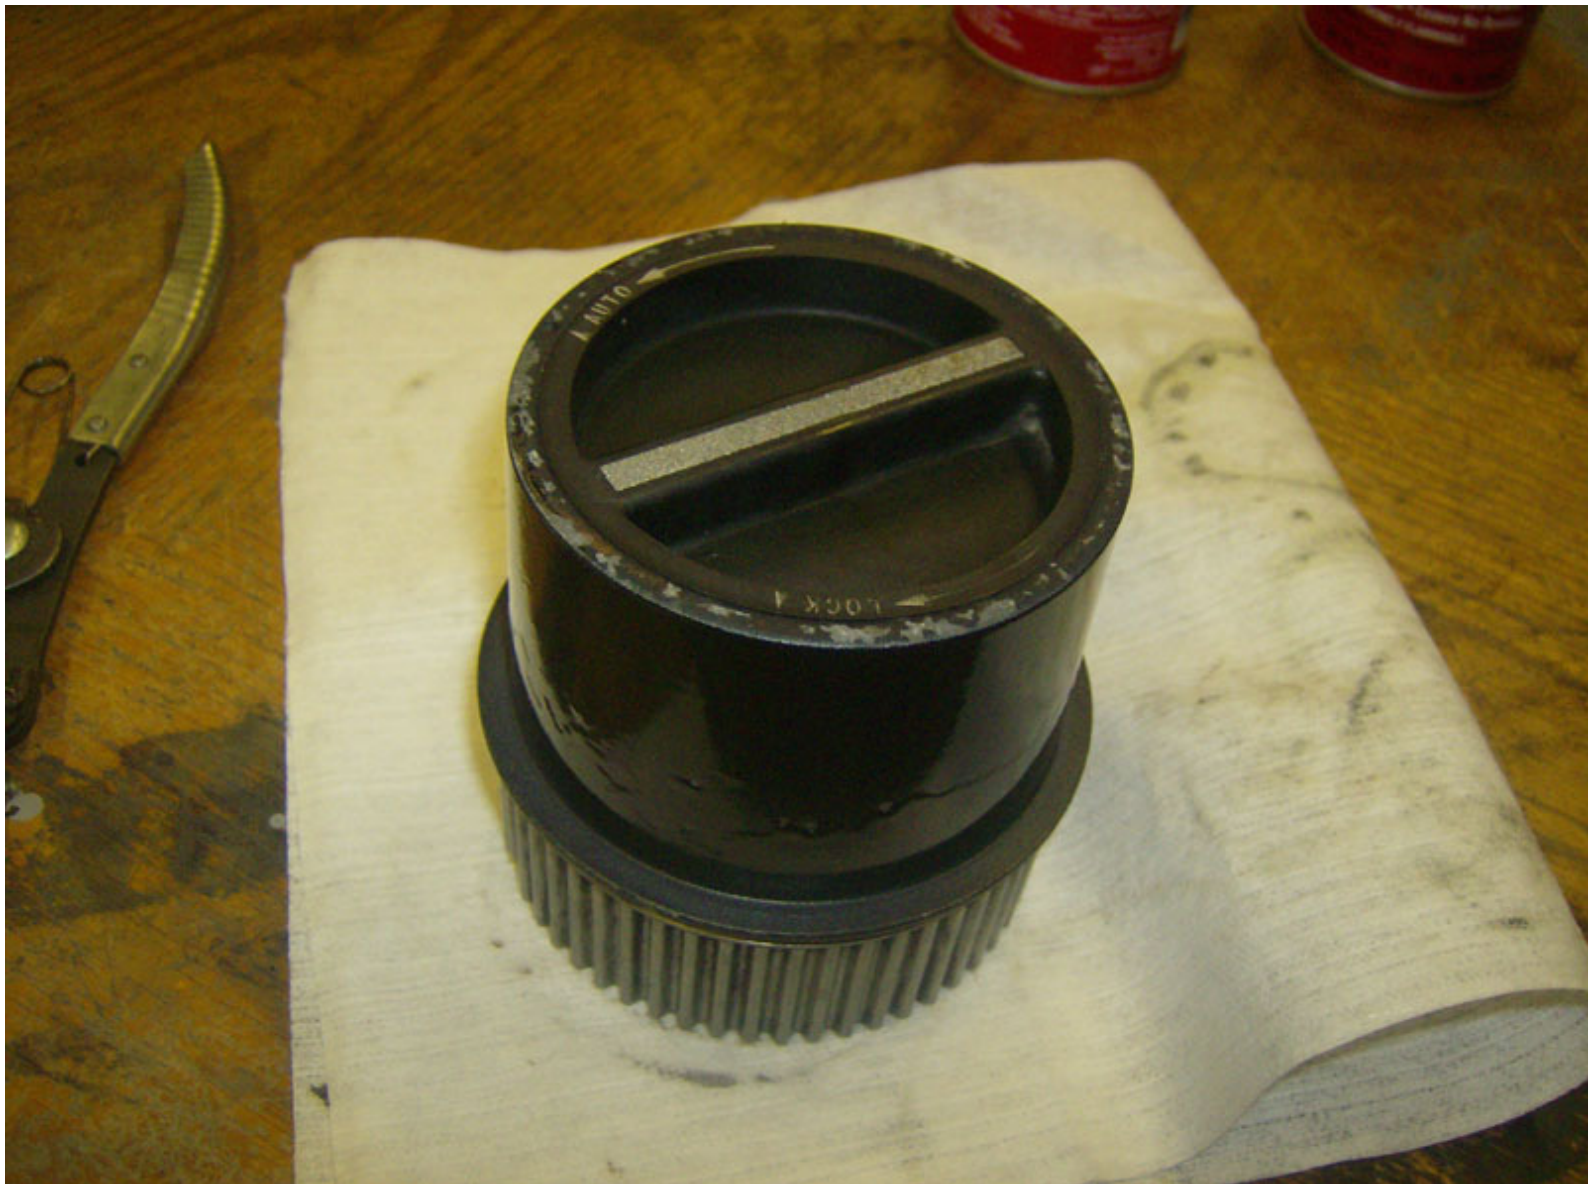
I did not paint the face of the hub because I didn't want to risk getting paint in the selector knob groove. Its hard enough to keep that knob moving freely!

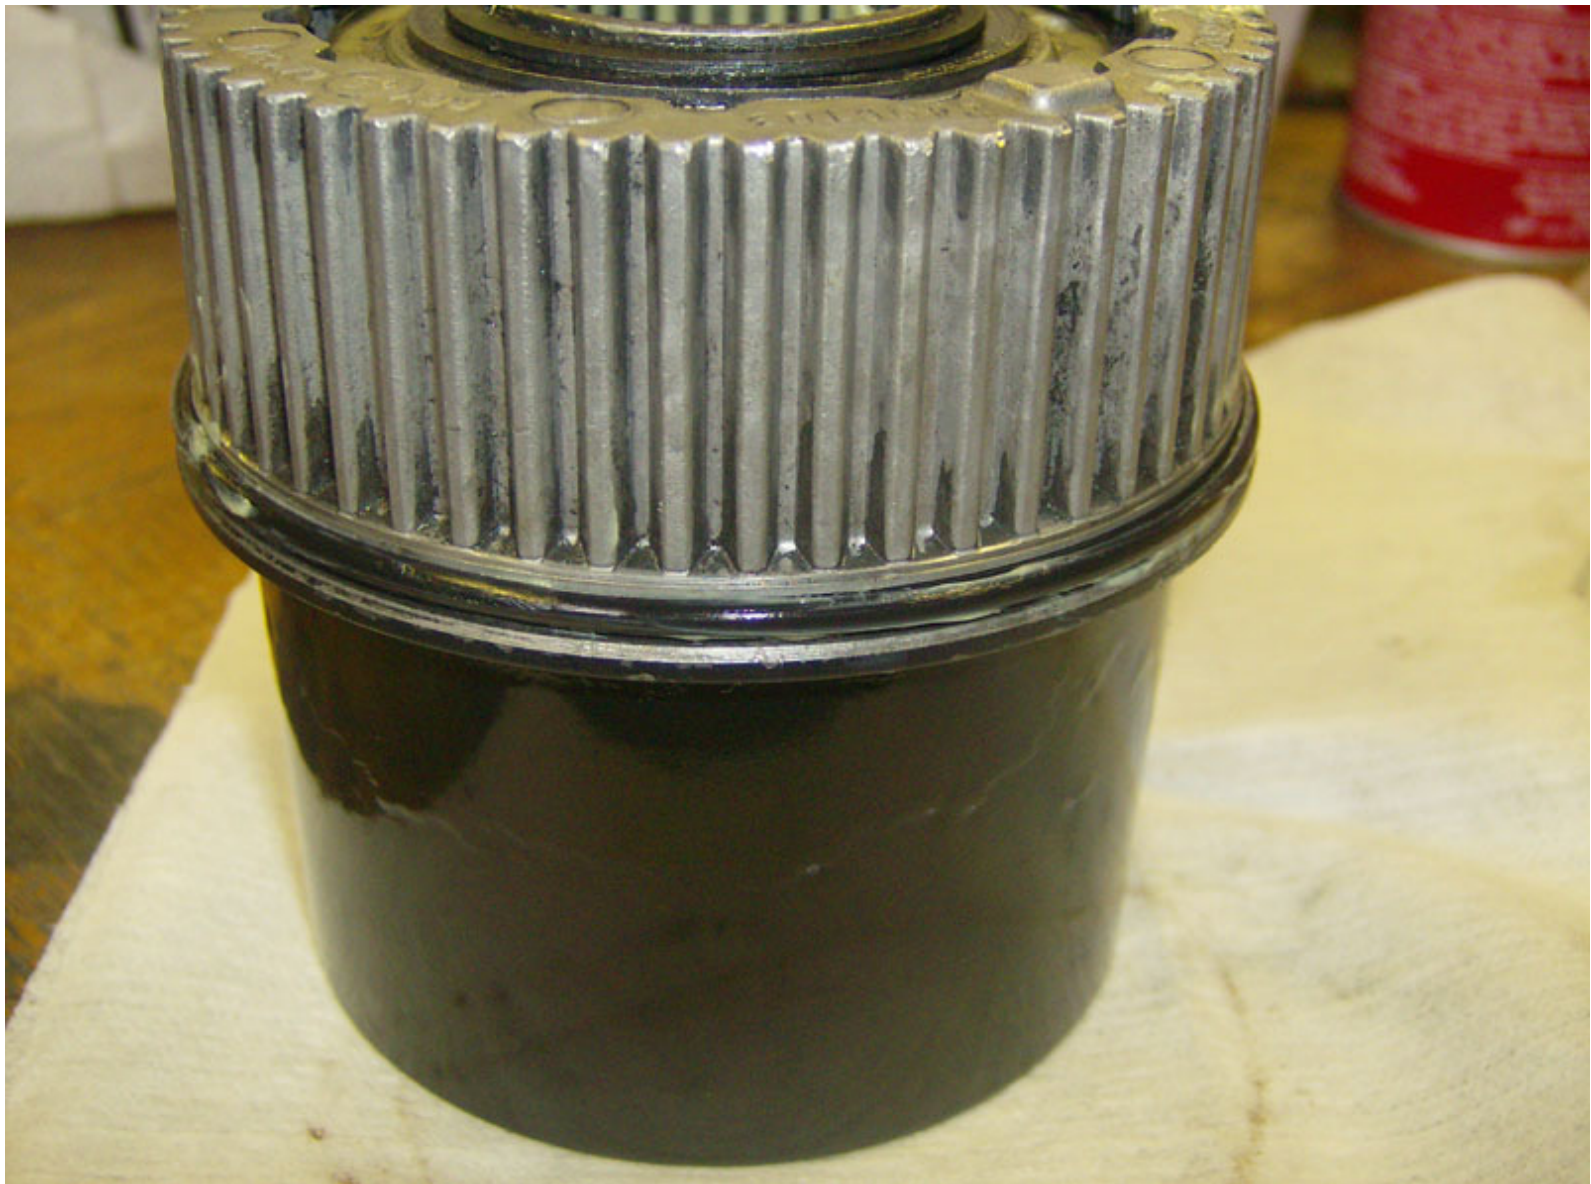
Last but not least, replace the black o-ring on the hub. You get two o-rings and one hub retaining ring in with Ford part number 4C3Z-1K106-AA. Remove the old one, clean out the groove, apply some white grease to the new one, and install it.
