Ford Super Duty 4x4 Slip Yoke Servicing

2004 F250 4x4 XLT Sport Crew Cab

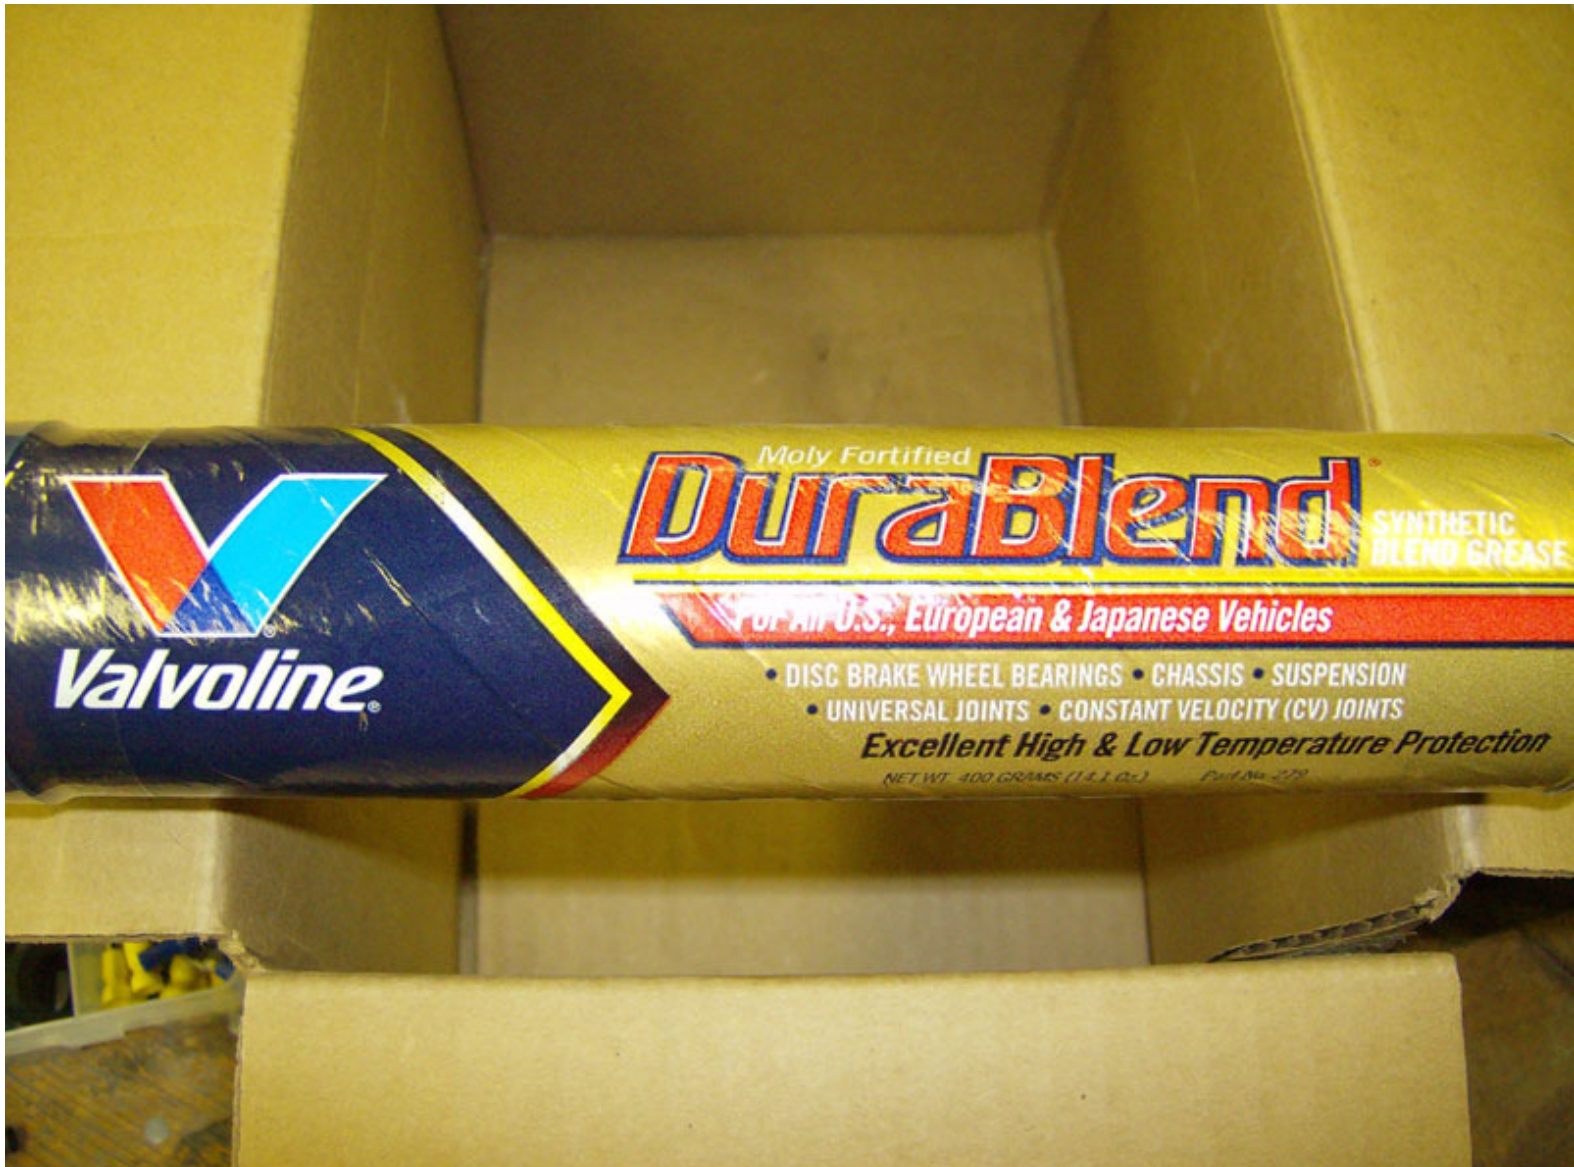
This picture shows how the slip yoke is arranged in my truck. I marked the orientation so that I could put it back exactly as it

was.

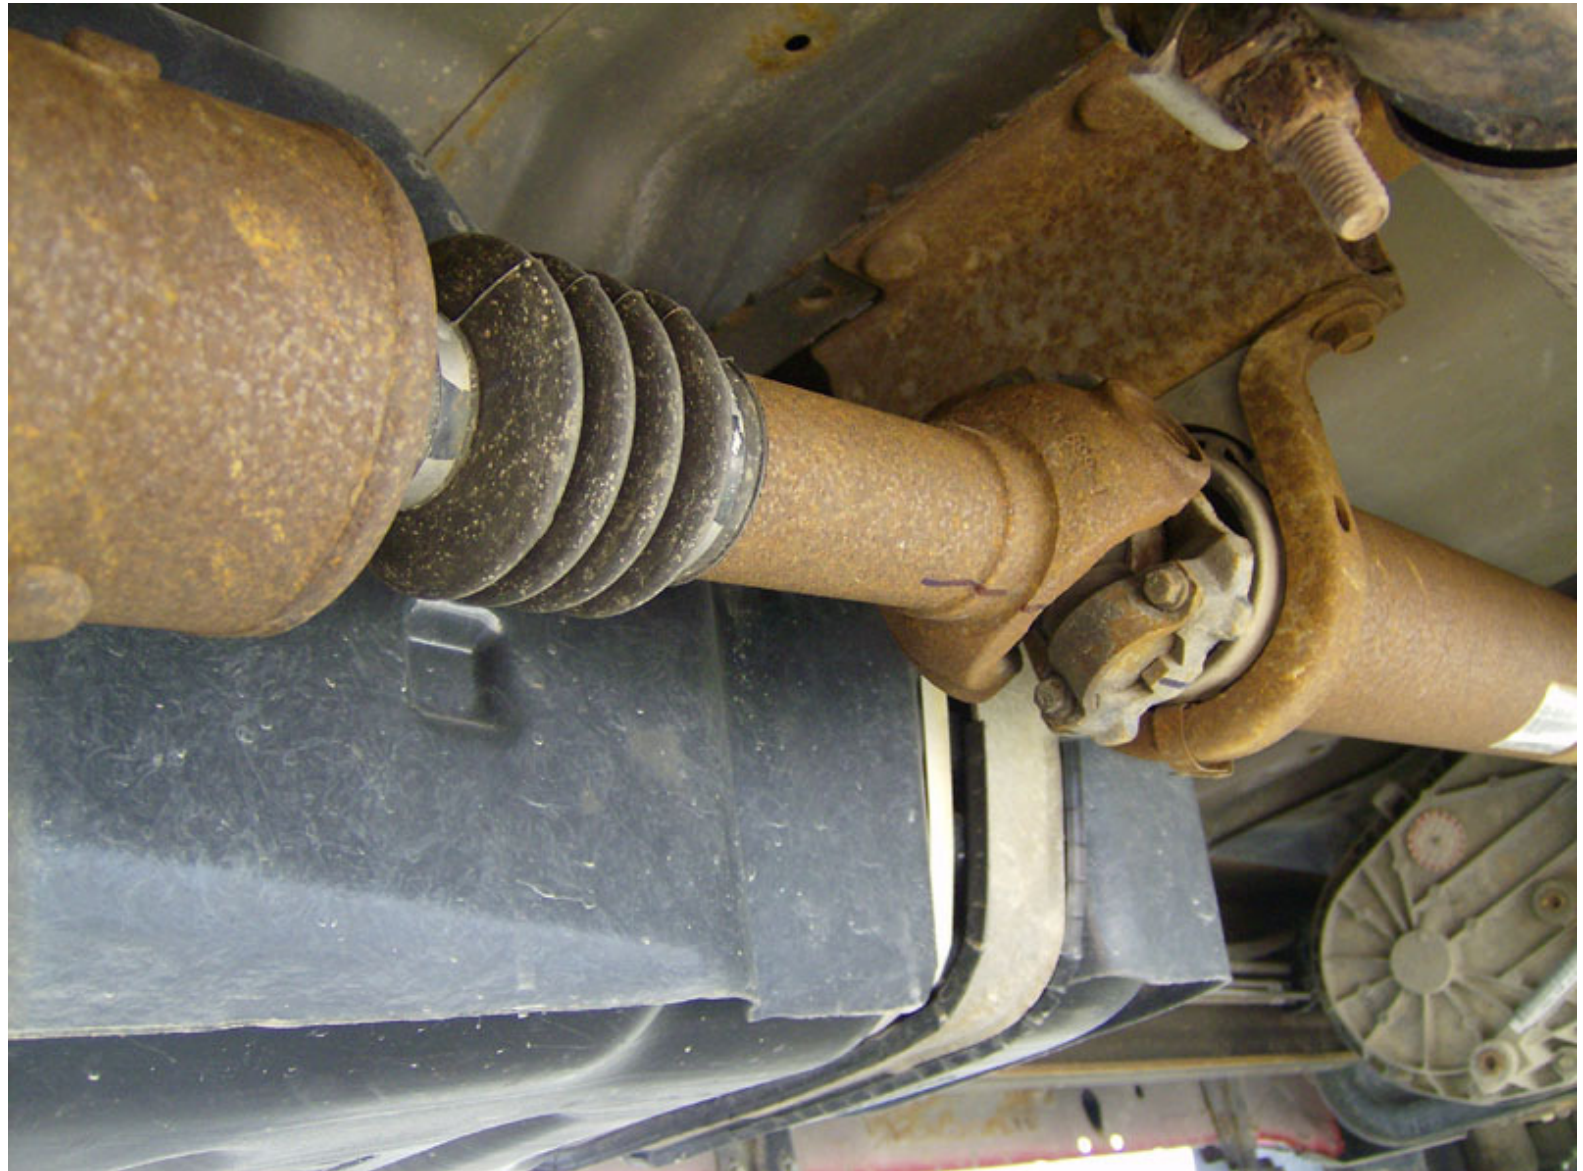
I spent some time making some unnecessary alignment marks. I've never had it apart before so I wasn't sure if there would be an opportunity to get the splines misaligned. Turns out you cannot connect the slip yoke incorrectly because there is one "double spline" allowing only one way to connect it. You only have to remove the front clamp (red arrow) to get it apart.

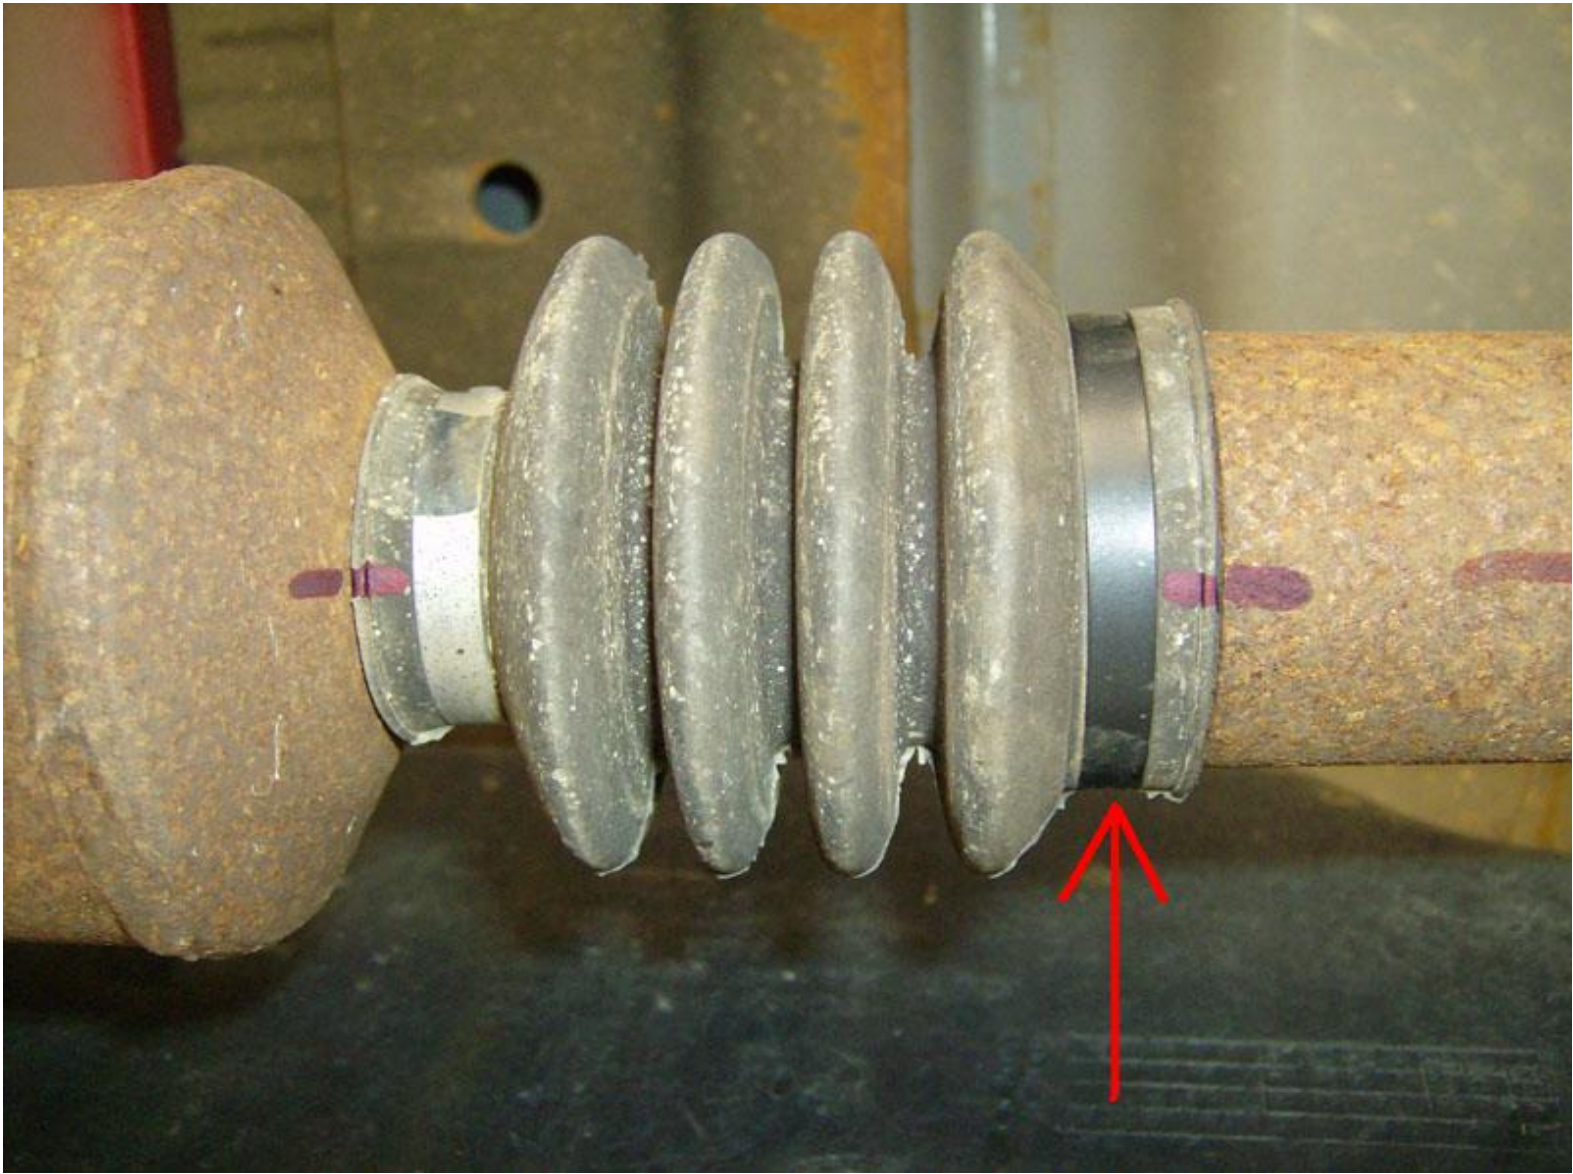
If you're careful, you can re-use this clamp. Otherwise, I think others have just used a cable tie.

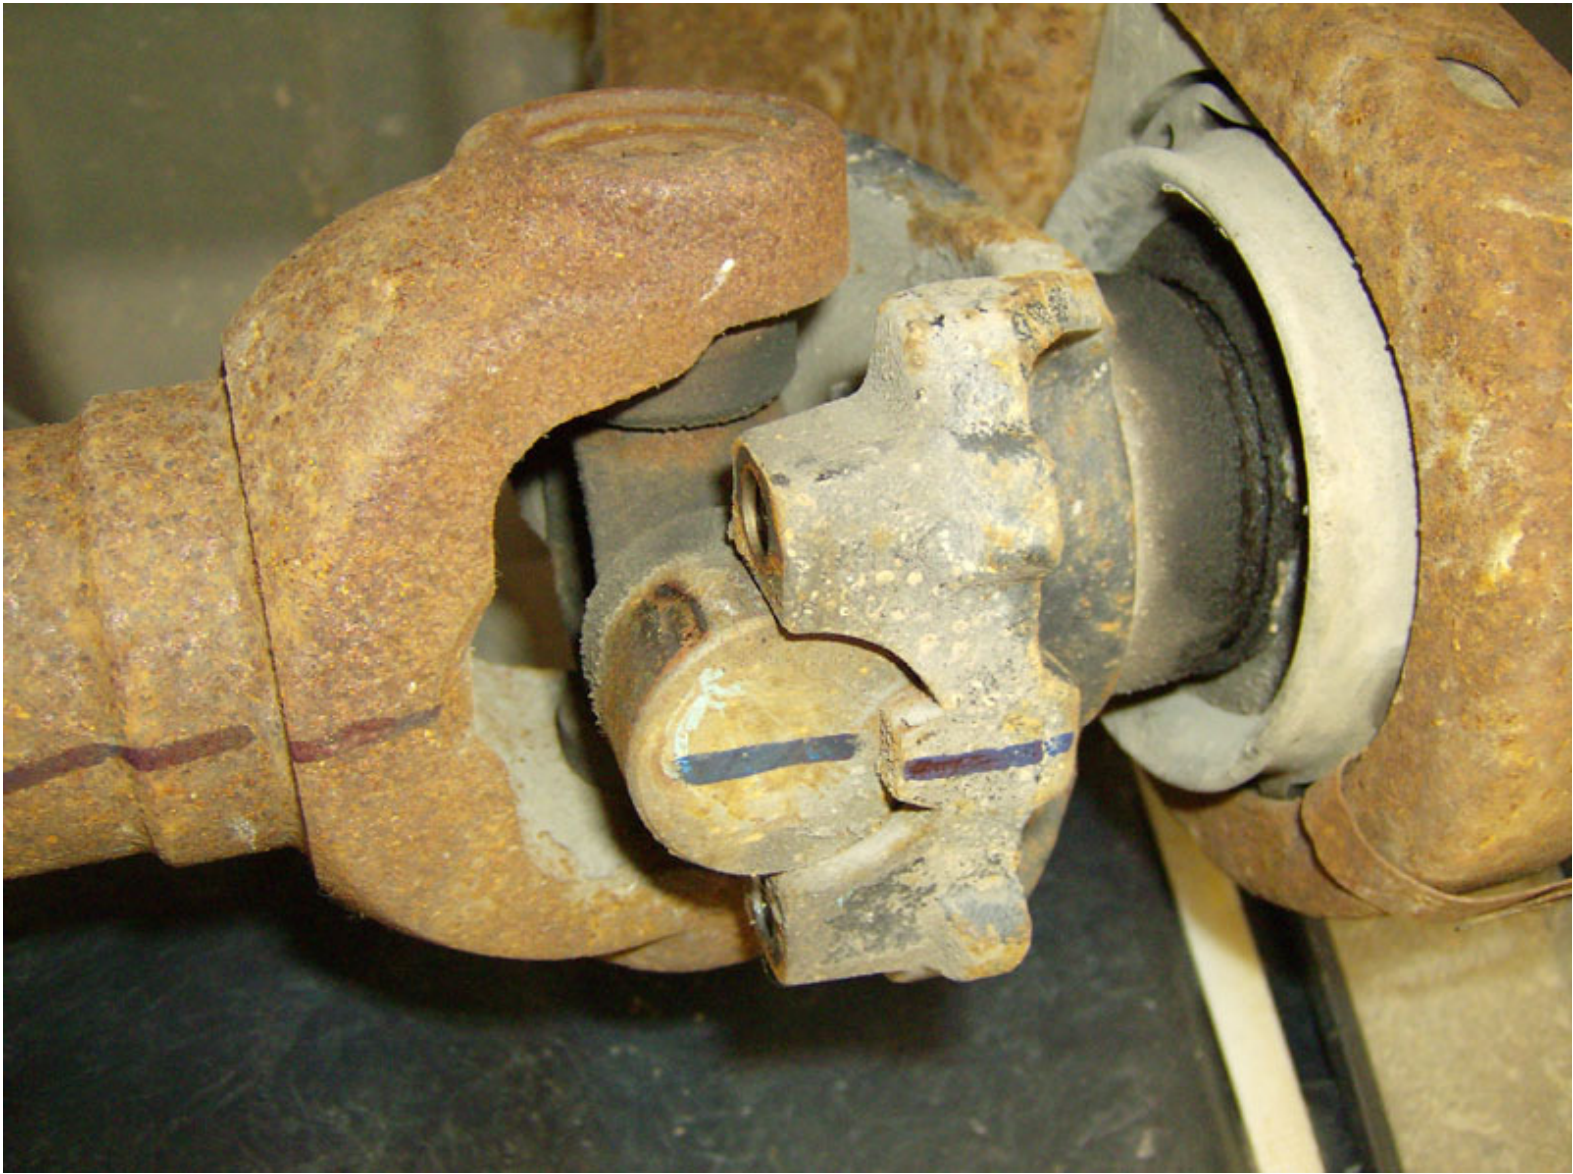
Slide it backwards a little, drop the driveshaft, and pull the slip yoke apart. Looks like it could indeed use a little more grease...

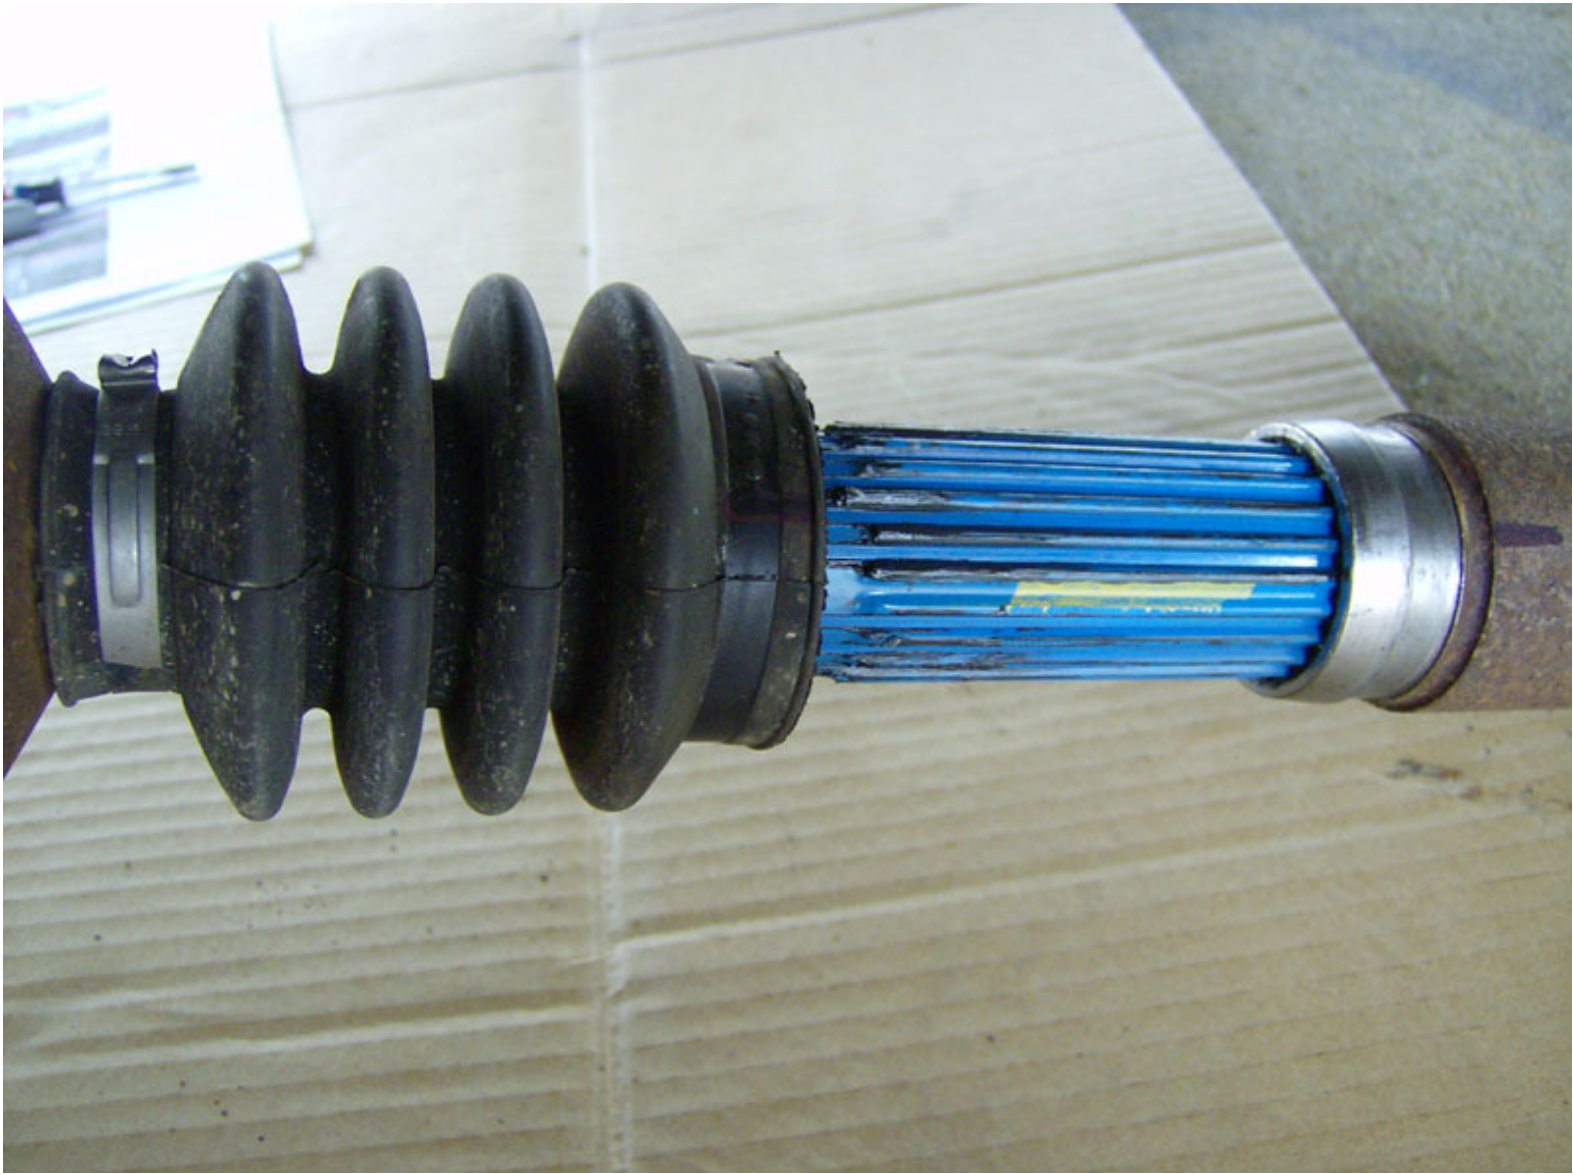
Looks a little dry down in there as well. You can see the "double spline" location on the right side in this pic.

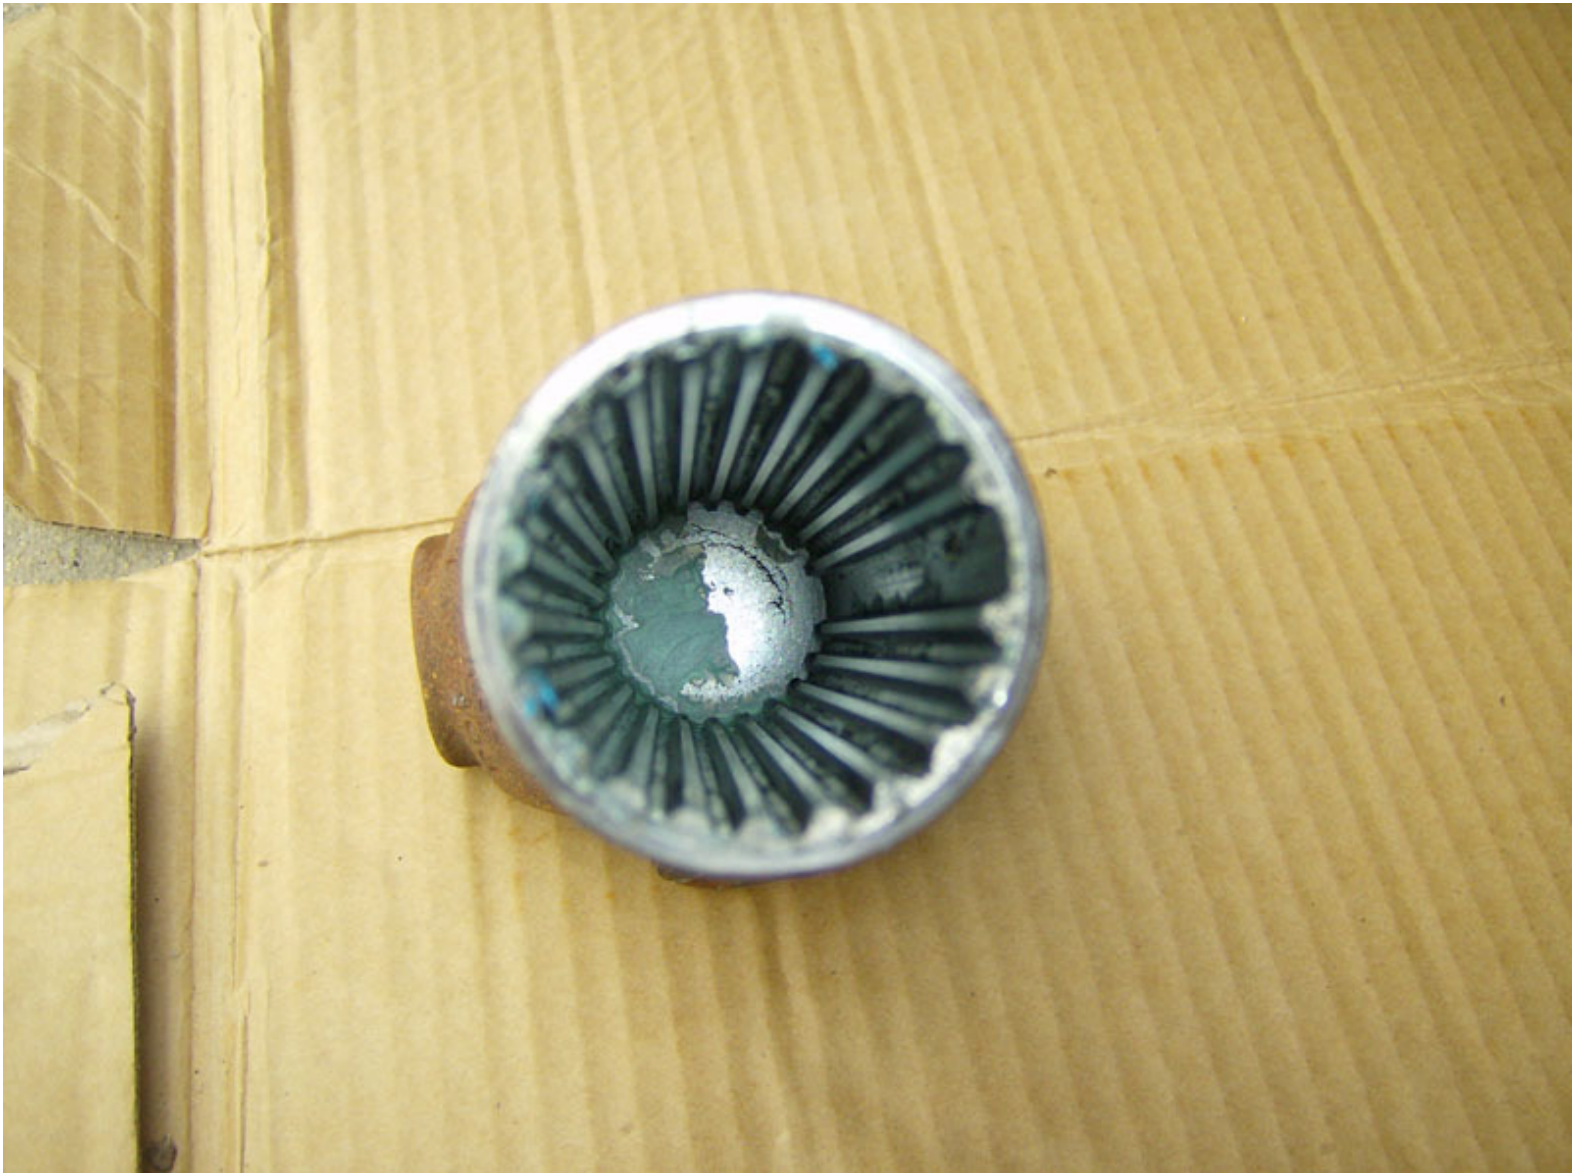
I applied plenty of grease to the splines. Way too much actually as most of it got pushed out when I reconnected the slip yoke assembly. Oh well, I'll know to use less next time!

Now, just reverse the removal steps and you're done. This turned out to fix the problem I was feeling. For the moment its smooth as glass on take-off, time will tell how long it lasts...
